JUNE 2017

The following is a monthly update for the Narrabri Community Consultative Committee (CCC) regarding activities undertaken by the NSW Environment Protection Authority (EPA) relating to PEL 238, PAL 2 and PPL 3 (Narrabri Gas Project).

The gas monitoring tools used by the NSW EPA

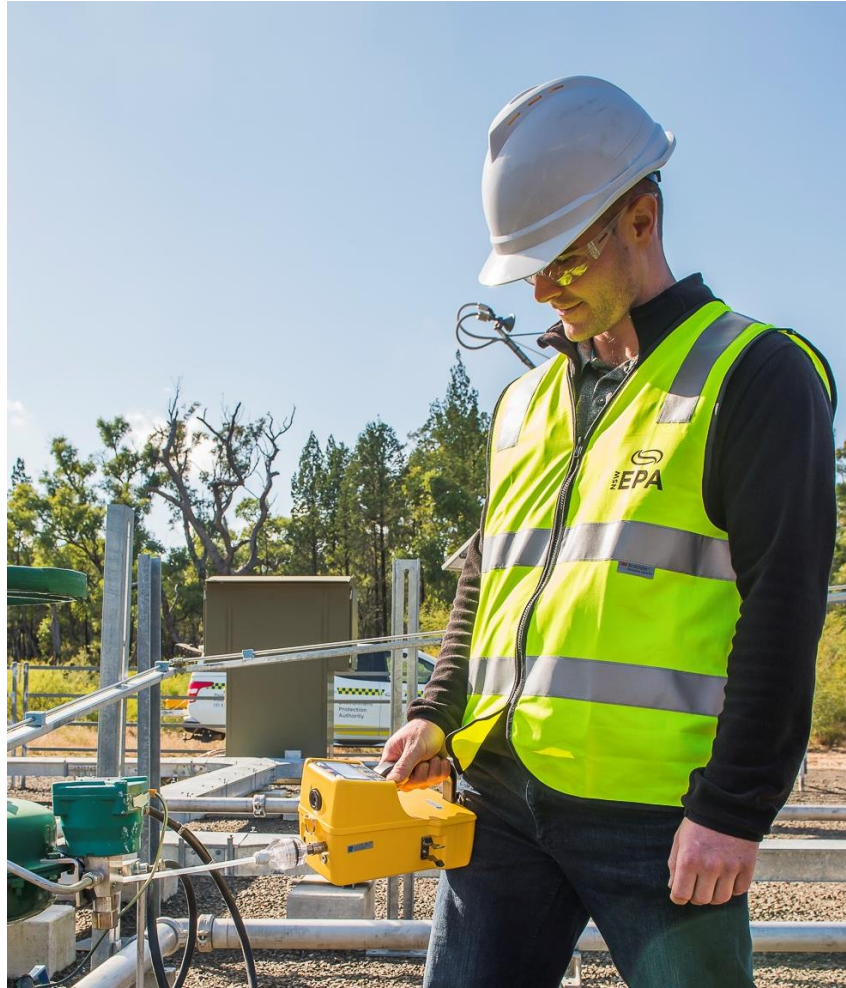
The Eagle 2 gas detector is versatile and detects specific gas such as methane, oxygen, hydrogen sulfide, carbon monoxide and carbon dioxide.

The Eagle 2 monitor is useful for measuring low concentrations of methane, and is accurate to ± 25 ppm.

The Eagle 2 uses a catalytic combustible sensor (LEL Sensor) to measure methane and other combustible hydrocarbons as either a percentage (%) or ppm. The detection principal is based on the catalytic oxidation of combustible gases – like the catalytic converter in your car, methane reacts with the catalyst in the sensor and 'burns off'.

The instrument detects the increased temperature and determines the amount of combustible gas present. Although calibrated against methane, this sensor can respond to other combustible gases such as hexane, propane, butane, acetone etc.

Picture: An EPA operations officer holding the Eagle 2 gas monitor

The Eagle 2 monitors are calibrated every six months as per the manufacturers specifications. The monitors are calibrated by the authorized service provider, Control Equipment, which is a specialist in gas detection equipment.

The instruments are labelled with a calibration sticker each time they are recalibrated, ensuring that every time the instrument is used the operator knows it is within calibration.

The monitors have built in filters which are present in the probe to prevent unwanted material entering the instrument. These filters can be replaced as necessary.

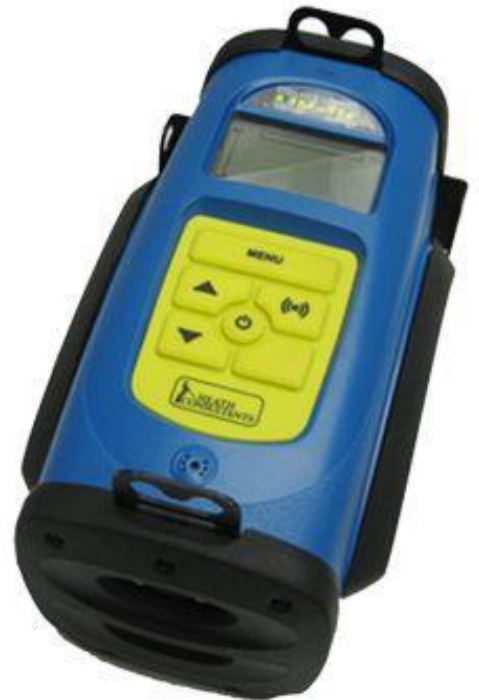
The DP-IR is a very sensitive gas detector that is used to detect methane in the environment. The detector can measure methane down to ppm with an accuracy of $\pm 10\%$.

The DP-IR uses an advanced optical method called infrared controlled interference polarization spectrometry to detect and measure the concentration of methane gas.

This instrument is highly selective to methane gas and is less susceptible to false alarms in the presence of other hydrocarbon gases.

It has an internal calibration cell that verifies instrument is giving accurate results. It also continuously monitors internal parameters to ensure they are within operational limits.

Picture: The DP-IR gas monitor

The DP-IR monitor comes calibrated from the factory and does not require regular recalibration as it uses an Infrared optical detector and has an in-built calibration cell.

The instrument has a built in self-test which is performed before use and checks against the internal calibration cell.
