# 5 RESULTS

The following comments on results should be read in conjunction with their corresponding FAOA Map Plots (see **Sections 5.1 to 5.11**). The likely source/s mentioned in these results is based on the odour character/s detected and position of the facilities relative to the wind direction i.e. whether the facility was upwind or downwind.

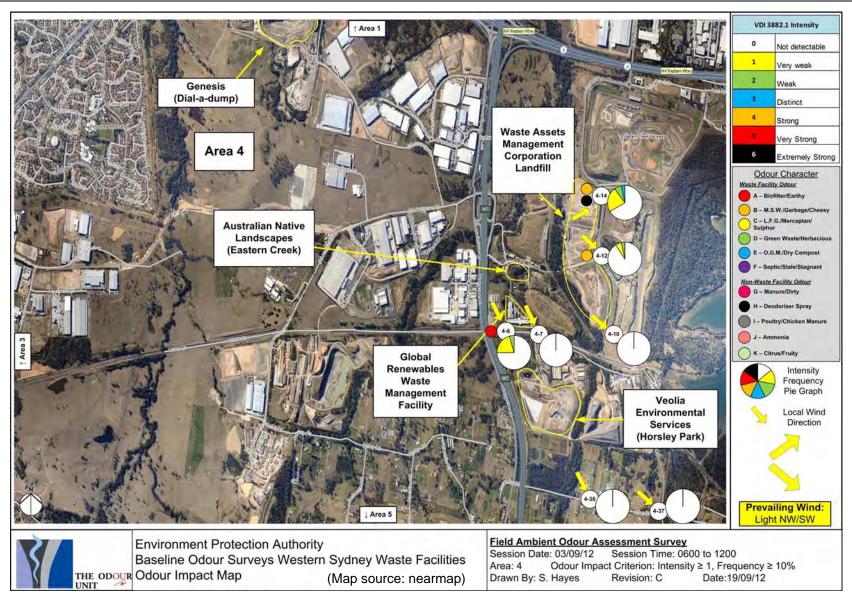
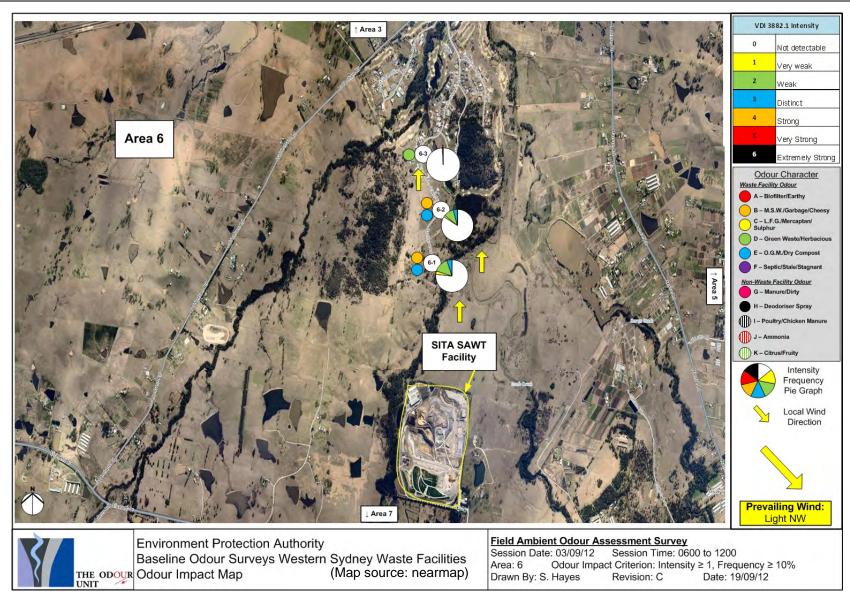
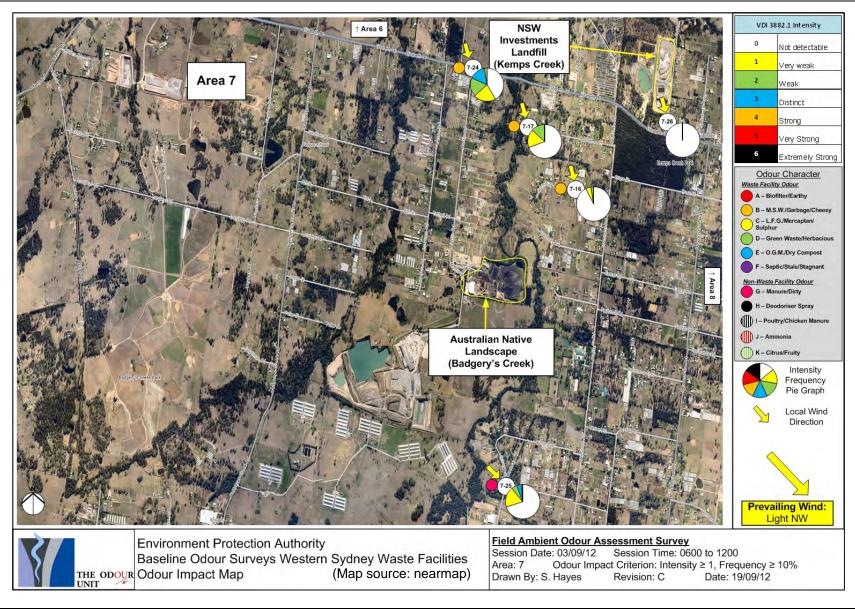
## 5.1 3 SEPTEMBER 2012 - MORNING

There was an instance at MLP 4-6 whereby a very weak to weak Manure / Dirty odour was detected south of the Global Renewables Facility. The likely source would have been from a piggery nearby.

At MLPs 4-12 and 4-14, very weak to distinct MSW / Garbage / Cheesy odour was detected east of WAMC Landfill along Ferrers Rd. The likely source would have been from the WAMC Landfill.

There were multiple types of odours detected on this occasion north of the SITA SAWT Facility see MLP's 6-1 to 6-3). The odour intensity was generally weak to distinct with MSW / Garbage / Cheesy, Greenwaste / Herbacious and Dry Compost odour characters. This represented moderate odour presence in the area and was detectable approximately 1.5 km from the northern boundary of the SITA SAWT Facility. It was likely originating from the SITA SAWT Facility at the time.

There was a very weak to distinct MSW / Garbage / Cheesy odour detected southeast of the SITA SAWT Facility. This odour was detectable 2.5 km away (i.e. from the southern boundary to MLP 7-16). It was likely to have originated from the SITA SAWT Facility at the time.

There was also another instance at MLP 7-25 whereby a localised, very weak Manure / Dirty odour was detected south of the Global Renewables Facility. The likely source would have been from a piggery nearby.

No odour was detectable downwind of the NSW Investments Landfill at the time.

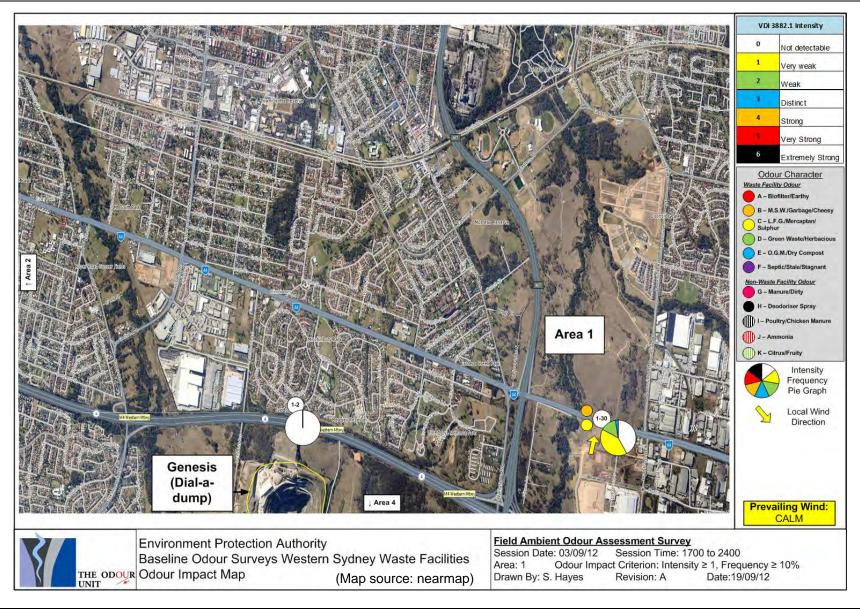
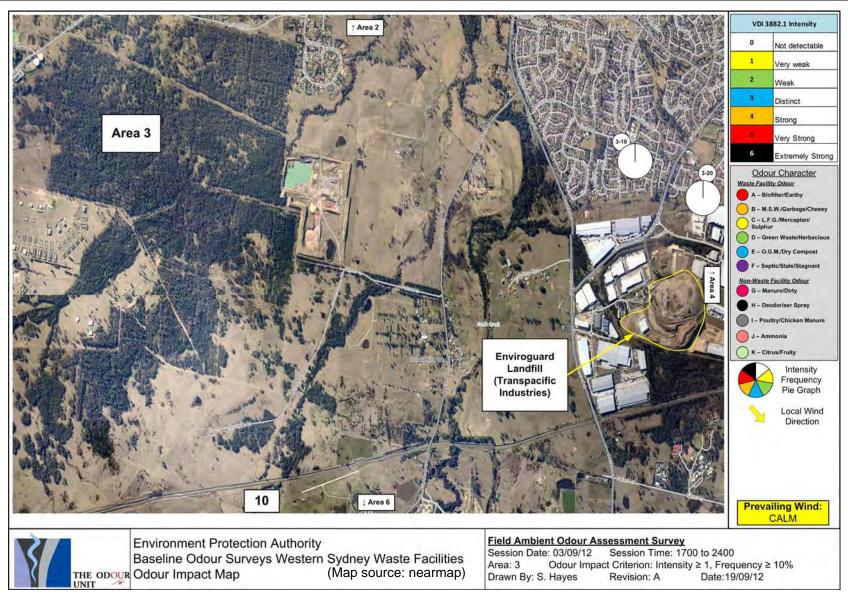
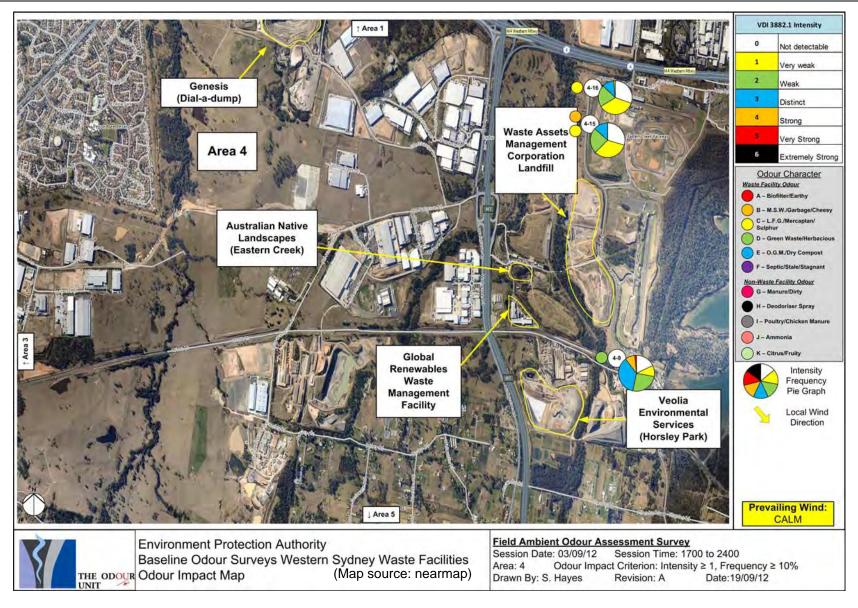
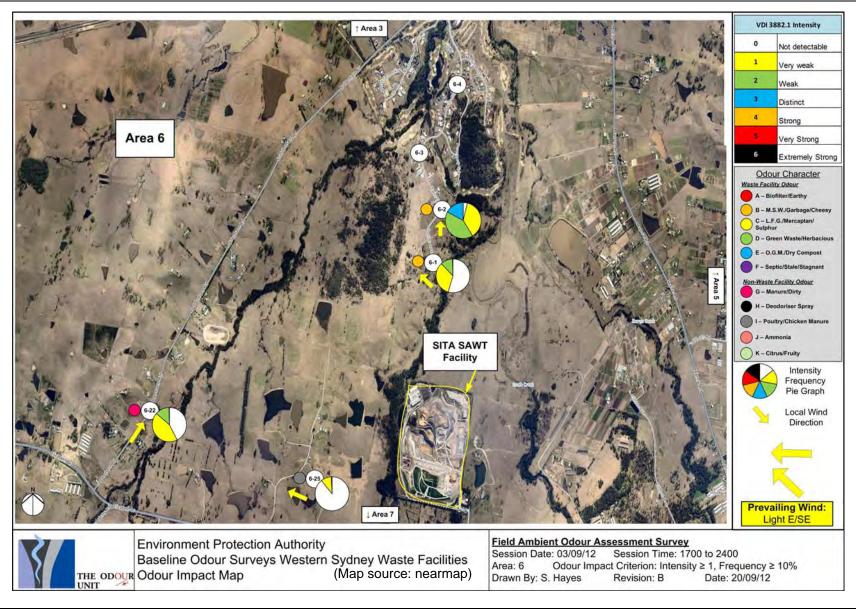
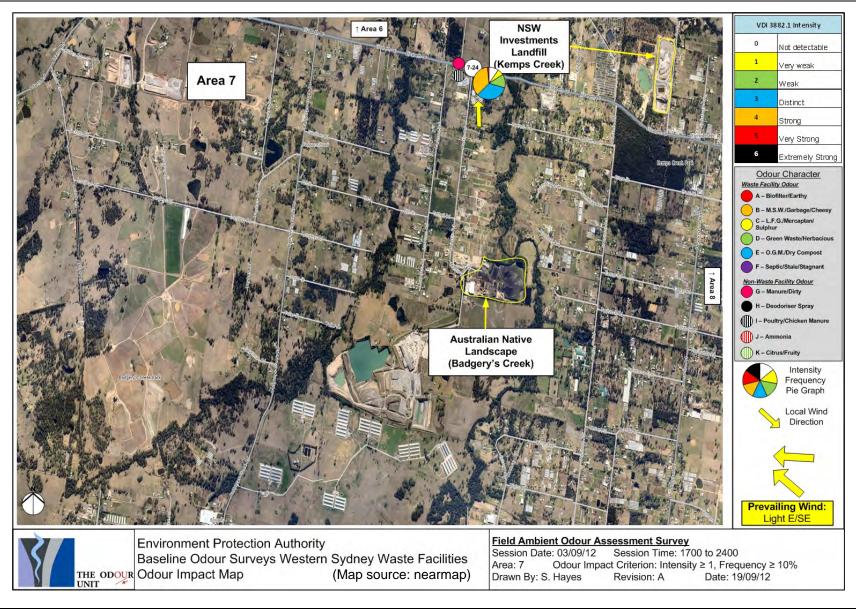
## 5.2 3 SEPTEMBER 2012 - EVENING

On this occasion, odour was present in Assessment Area 4 and was detectable as far as Area 1 (i.e. from MLP 4-15 to 1-30). This equates to approximately 1.5 km in distance. The odour detectable was generally very weak to distinct, becoming weaker as the assessors traversed downwind. The odours detected were MSW / Garbage / Cheesy and LFG / Mercaptan / Sulphur characters. The likely source would have been from the WAMC Landfill at the time.

In Assessment Area 4, distinct to strong Greenwaste / Herbacious odour was detectable southeast of the Eastern Creek Precinct at this time. The odour would have likely originated from the Global Renewables Facility at the time.

This session detected MSW / Garbage / Cheesy odour at very weak to distinct intensities on Humewood Place, Twins Creek (i.e. north of the SITA SAWT Facility and downwind). The likely source of the odour would have been the SITA SAWT Facility at this time.

Other odour was also detectable at very weak to weak intensities that were likely from poultry farms and piggeries residing in this Assessment Area.

A distinct to strong Poultry/Piggery based odour was detectable along Elizabeth Drive at MLP 7-24. The likely source would have been from a multitude of farms and piggeries residing within the vicinity of the assessment locations.

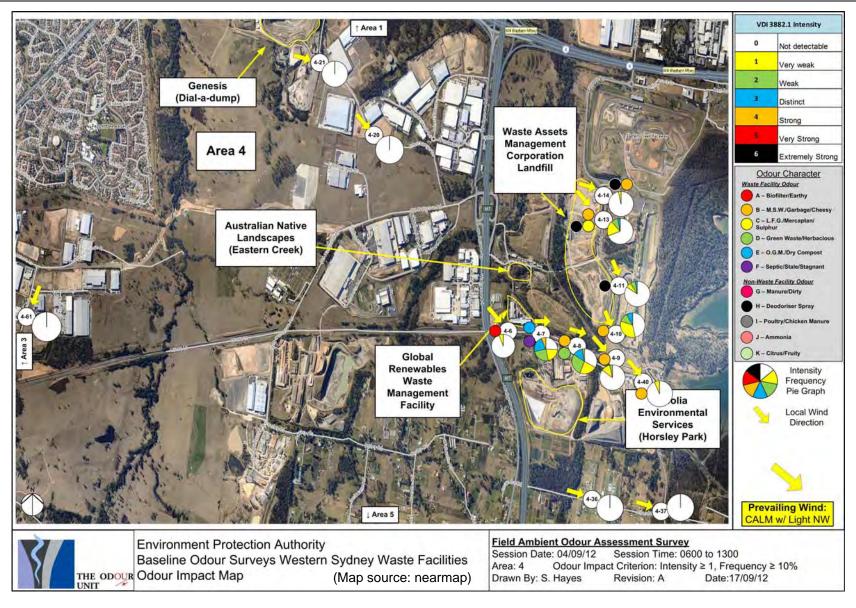
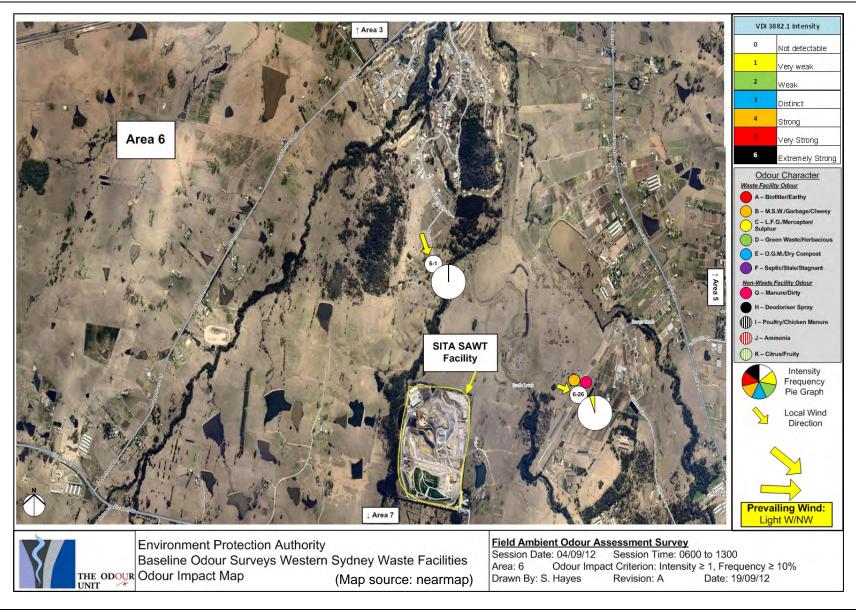
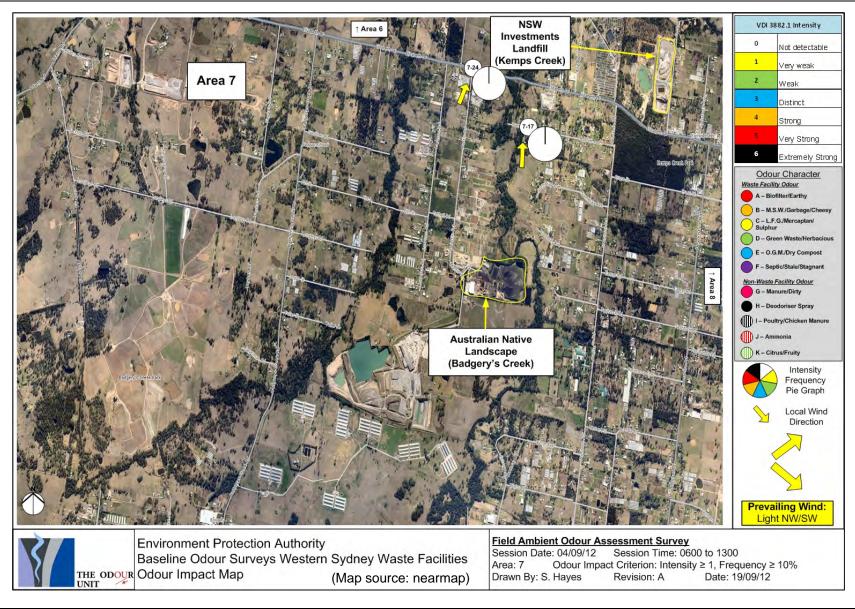
### 5.3 4 SEPTEMBER 2012 - MORNING

On this occasion, odours were detectable within the Eastern Creek Precinct, along the Austral Bricks Private Road and varied as the assessor traversed east along this road and onto Ferrers Rd. The odours were detectable at very weak to distinct intensities and ranged from Biofilter / Earthy and OGM (MLPs 4-6 and 4-7) characters, changing to Greenwaste / Herbacious and MSW / Garbage / Cheesy (MLPs 4-8 to 4-11, 4-13, 4-14 and 4-40) characters further downwind.

Deodoriser spray odour was also detectable along Ferrers Rd, east of the WAMC Landfill. The likely sources of these odours at the time would have been a combination from the Global Renewables Facility (MLPs 4-6 to 4-8) and WAMC Landfill (MLPs 4-8 to 4-11, 4-13, 4-14 and 4-40).

No odour was detectable downwind from Veolia Environmental Services (Horsley Park) and the Genesis Landfill on this occasion (see MLPs 4-20 and 4-20).

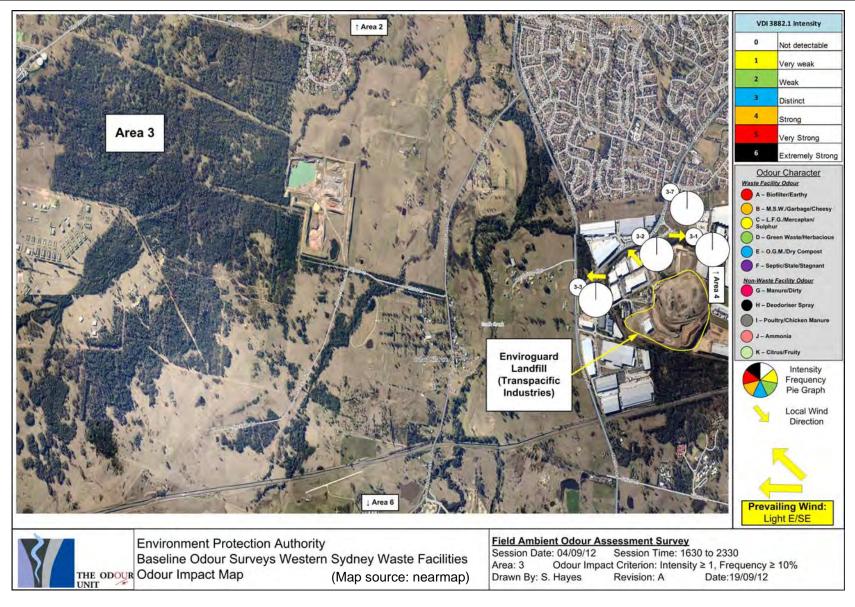
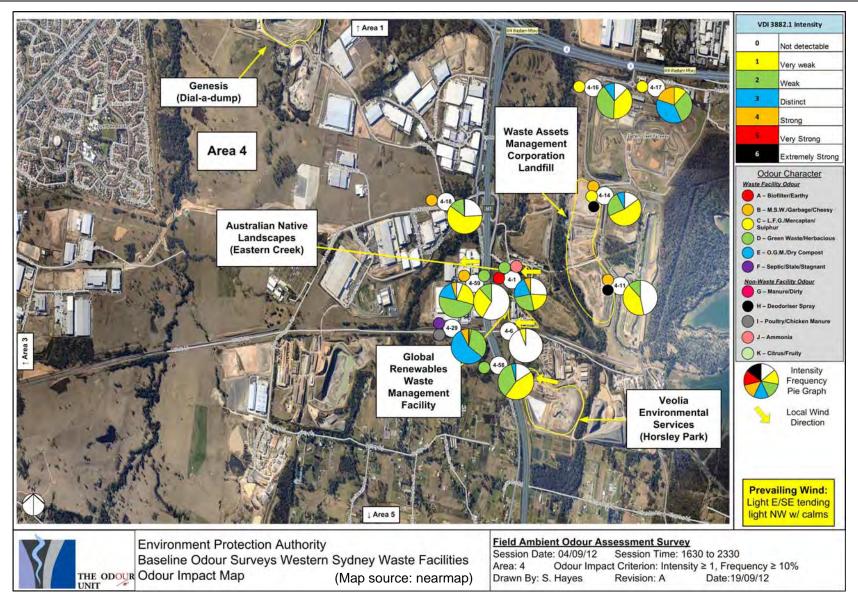
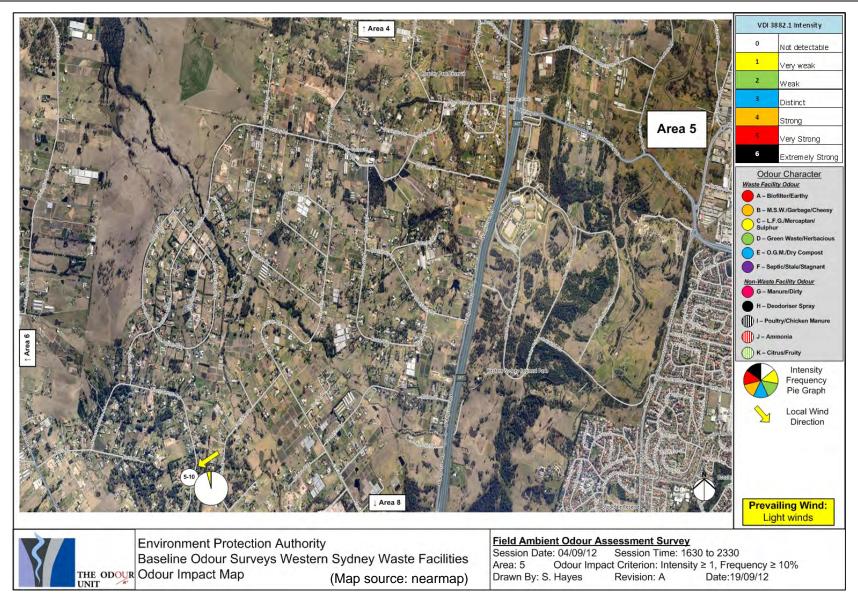
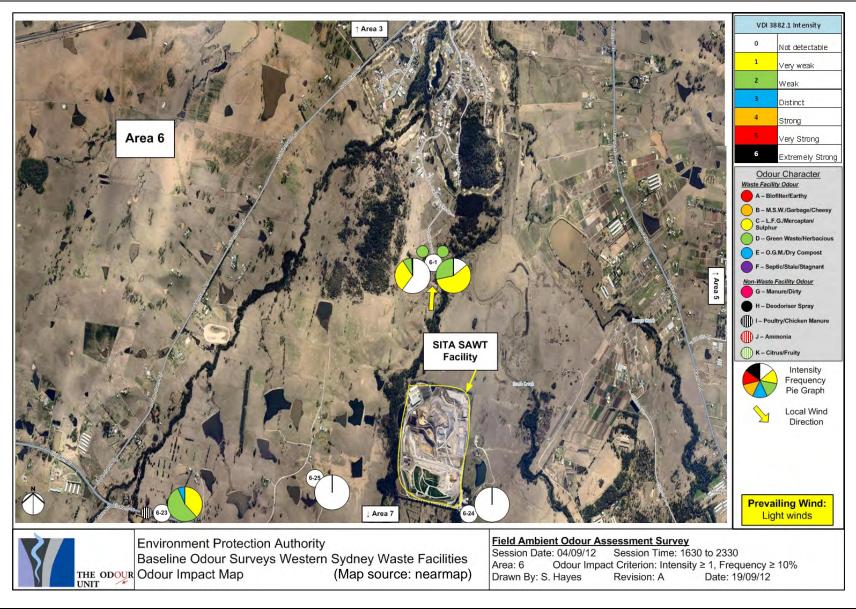
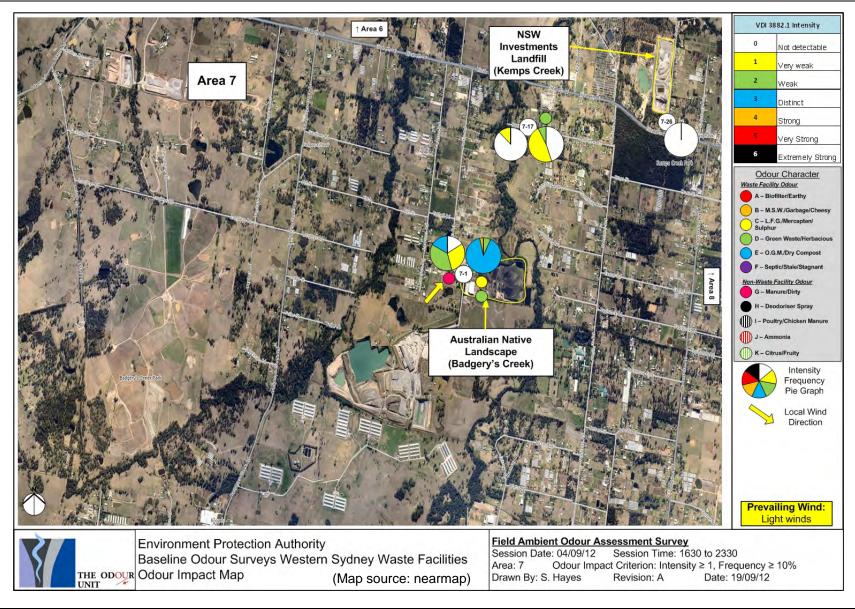
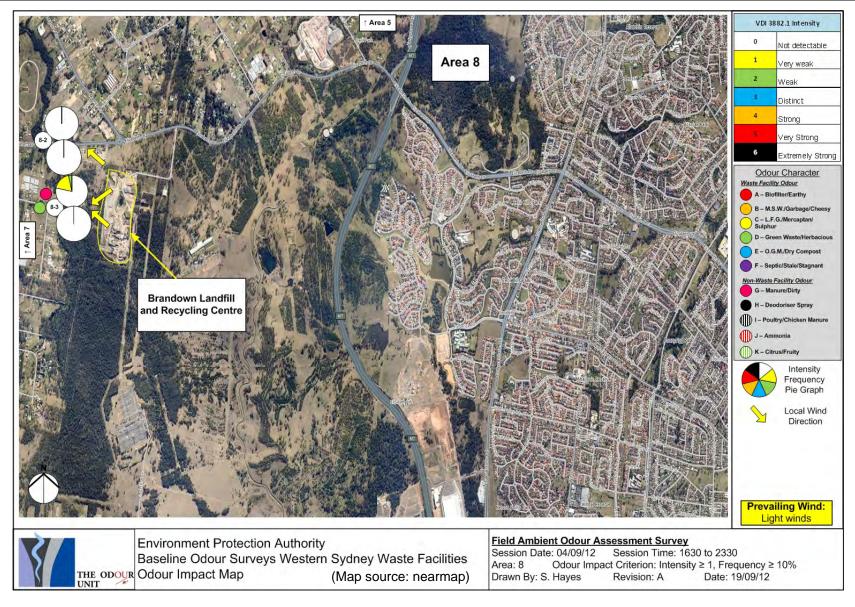
## 5.4 4 SEPTEMBER 2012 - EVENING

On this occasion, odour was detected at weak to distinct intensities; approximately 500 metres west of the Global Renewables Facility (see MLPs 4-1, 4-18 and 4-59). A myriad of odours were detectable including MSW / Garbage / Cheesy, Biofilter / Earthy and Greenwaste / Herbacious. These were likely originating from the Global Renewables Facility at the time.

Odours were also detected from the WAMC Landfill on this occasion, beyond the boundary at very weak to distinct intensities at the time along Ferrers Rd. The odour characters were MSW / Garbage / Cheesy and LFG / Mercaptan / Sulphur. These odours were also detectable further downwind, approximately 1 km from the site's northern boundary (see MLPs 4-16 and 4-17).

It is possible that both the Global Renewables and WAMC Landfill facilities were contributing to the MSW / Garbage / Cheesy odour detected on the west and east sectors of the Eastern Creek Precinct on this occasion.

Additionally, other odours were detectable in the same Assessment Area (see MLP 4-29) that could be related back to piggery/poultry operations residing within the general area and not the waste facilities.

A very weak to weak Greenwaste / Herbacious odour was detectable along Humewood Place, Twin Creek (i.e. north of the SITA SAWT Facility) at this time. The odour would have likely originated from the SITA SAWT Facility.

A Poultry / Chicken Manure odour was also detectable along Elizabeth Drive (MLP 6-23) on this occasion. It was likely originating from the farming operations residing within this general area.

Distinct odours were detectable immediately downwind of the Australian Native Landscapes Facility (Badgery's Creek) site boundary (see MLP 7-1). The odours were LFG / Mercaptan / Sulphur and Greenwaste / Herbacious. The source could not be accurately determined, however, it is likely that the Greenwaste / Herbacious odour was emanating from the Australian Native Landscapes Facility (Badgery's Creek) and/or possibly the piggery farms residing within the vicinity of this area. This odour, however, was localised and not detectable further downwind from this point. The source of the LFG / Mercaptan / Sulphur could not be determined on this occasion.

Some weak to distinct intensities of Manure / Dirty odour was also detectable at MLP 7.1 during a second measurement by a different assessment team and was likely emanating from piggeries within the vicinity of this area.

On this occasion, odour was Manure / Dirty and Greenwaste / Herbacious odours were detectable at very weak intensities. It is unlikely that the source of this odour would have been emanating from the Brandown Resource Recycling Facility and Landfill. As such, the source could not be accurately determined on this occasion.

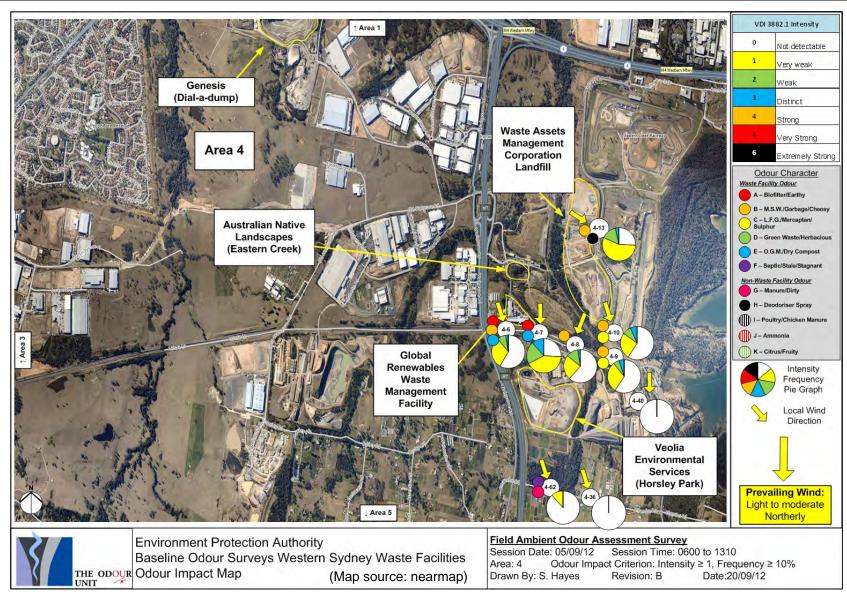
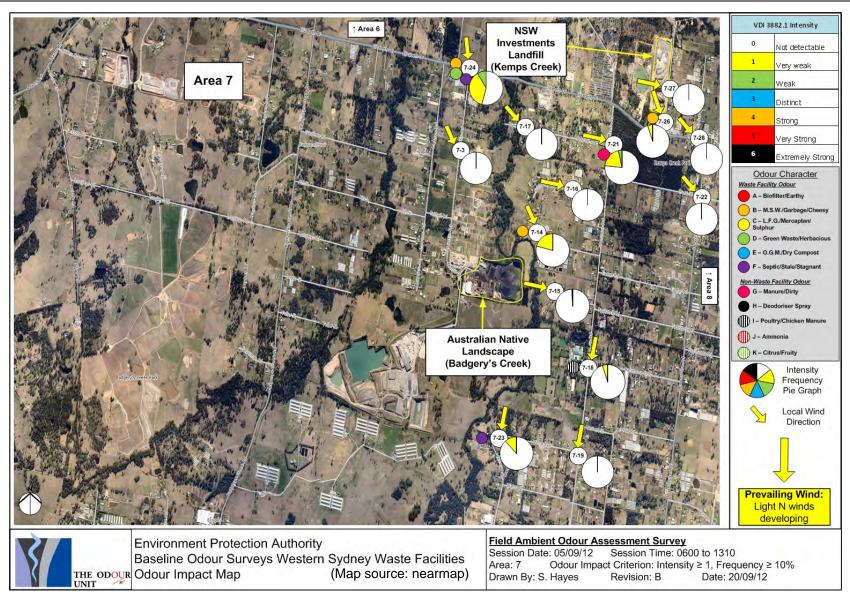
### 5.5 5 SEPTEMBER 2012 - MORNING

There were several odours detectable within the Eastern Creek Precinct on this occasion at very weak to distinct intensities (see MLPs 4-6 and 4-7). The odour characters included Biofilter / Earthy, MSW / Garbage / Cheesy and OGM. These odours were detectable downwind of the Global Renewables Facility, indicating that this would be the likely source at the time. As assessors traversed east of the Austral Brick Private Road (see MLPs 4-8 to 4-9), the OGM and Biofilter / Earthy odours were not detectable, however, a LFG / Mercaptan / Sulphur odour was detectable and likely originating from the WAMC Landfill.

All odours detected within the Eastern Creek Precinct were not detectable further downwind on this occasion (see MLPs 4-36, 4-40 and 4-62).

Some very weak MSW / Garbage / Cheesy was detectable, however, at intermittent frequencies on this occasion. The assessors did note that Council Trucks were heavily active in the area. This was likely the source of the intermittent MSW / Garbage / Cheesy odour at MLPs 7-24 and 7-26, and was not likely from the SITA SAWT Facility on this occasion.

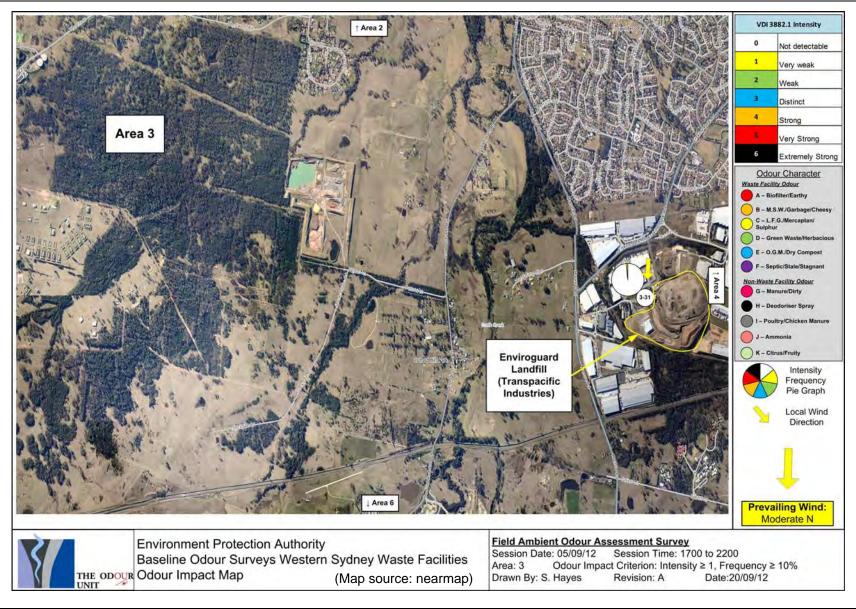
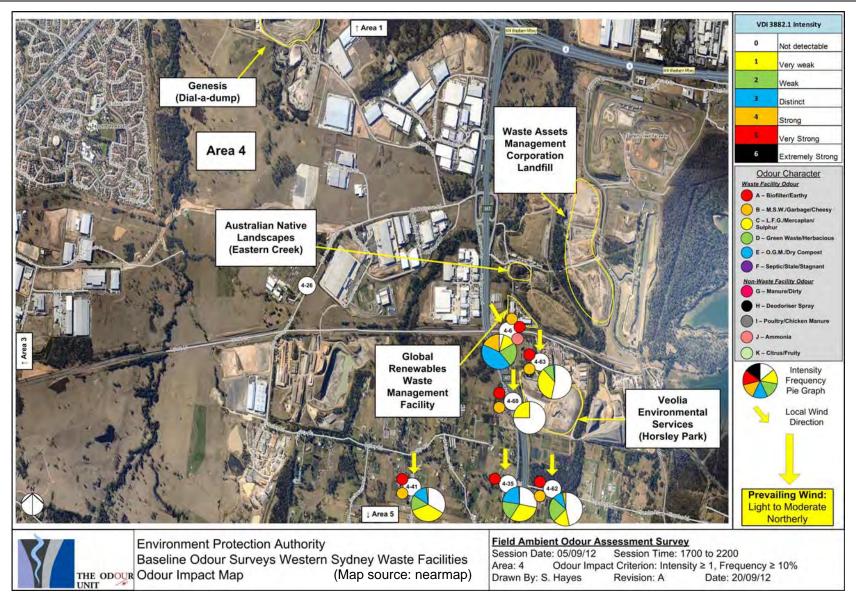
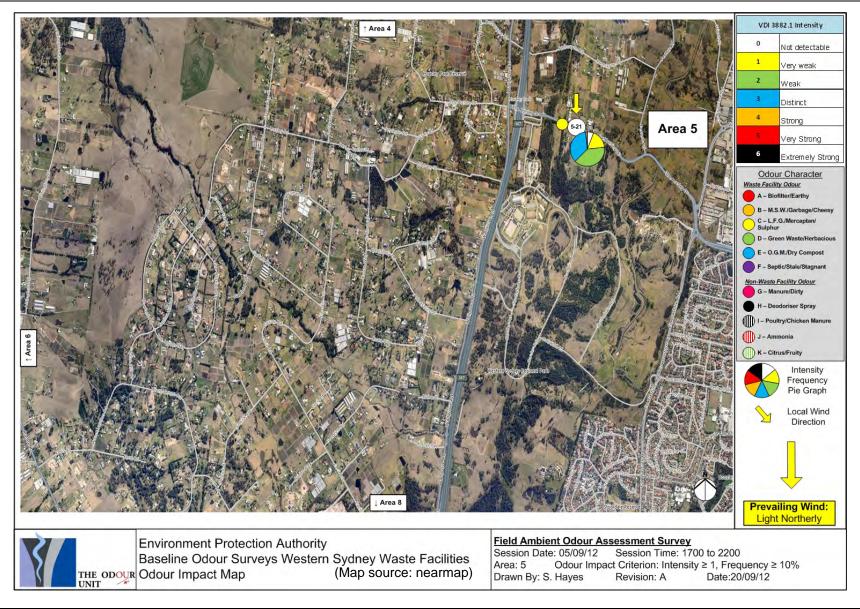
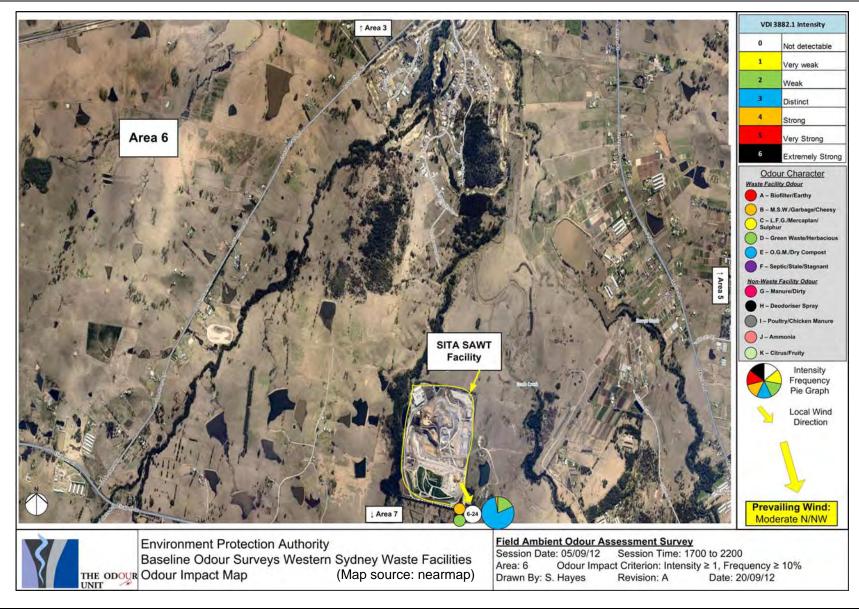
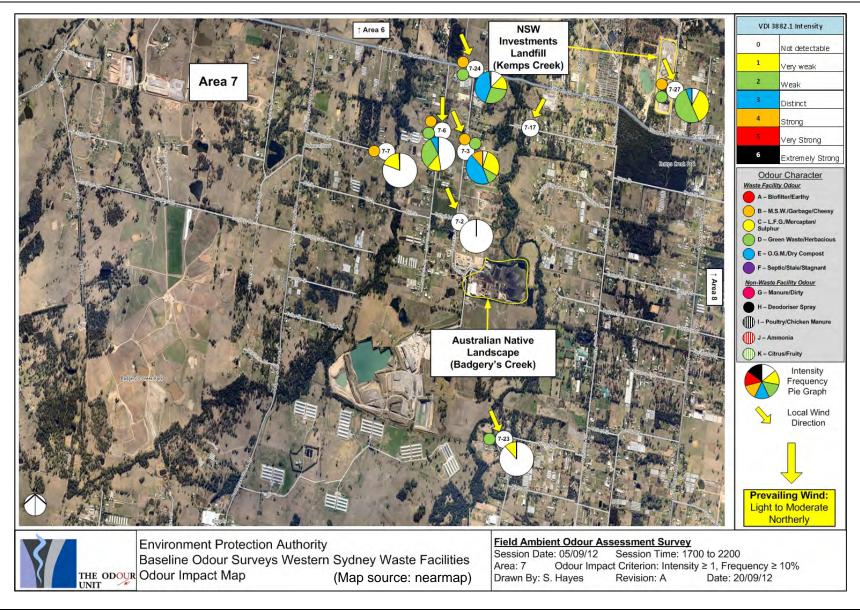
### 5.6 5 SEPTEMBER - EVENING

On this occasion, odours were detected at very weak to strong intensities. The odour characters were a combination of Biofilter / Earthy and MSW / Garbage / Cheesy. The odours were found to travel approximately 1.5 km downwind from the southern boundary of the Global Renewables Facility. The biofilter emissions were judged to be the main contributor (see MLPs 4-6, 4-63, 4-60, 4-41, 4-35 and 4-62). These were likely originating from the Global Renewables Facility.

No significant odour was detectable downwind of the Veolia Environmental Services (Horsley Park) Landfill on this occasion.

On this occasion, a very weak to distinct LFG / Mercaptan / Sulphur odour was detectable within the vicinity of Wallgrove Rd and The Horsley Drive (MLP 5-21). It was difficult to accurately determine the likely source on this occasion as it was not detectable on any other occasion during this assessment session. It is likely to have been a localised incident.

There was very weak to distinct MSW / Garbage / Cheesy and Green/Herbacious odour detectable up to 2 km downwind from the southern boundary of the SITA SAWT Facility. On this occasion, all odours detectable in these two areas are likely to have been originating from the SITA SAWT facility
