## EPA AUDIT REPORT – BODALA STATE FOREST, COMPARTMENT 3010

# AUDIT FINDINGS TABLE – BODALLA STATE FOREST, COMPARTMENT 3010

## FURTHER OBSERVATIONS TABLE – BODALLA STATE FOREST, COMPARTMENTS 3010 AND 3011

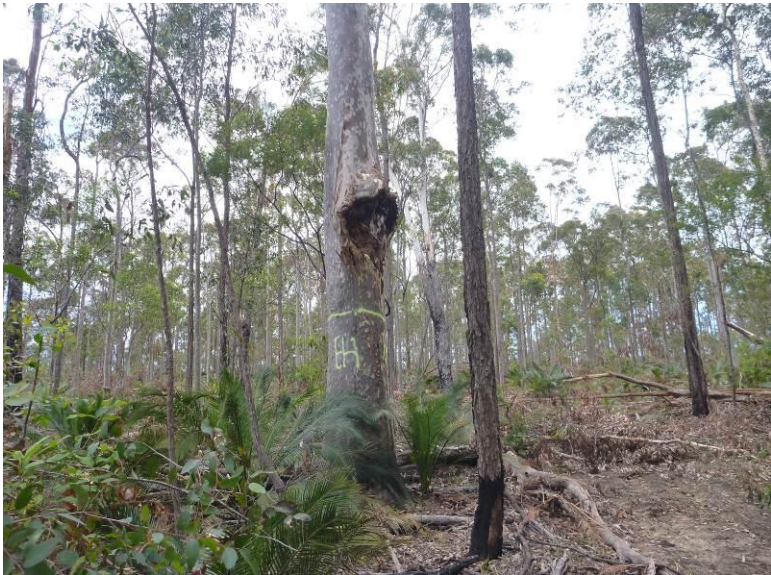
<p>(i) a minimum of five hollow bearing trees must be retained per hectare of net logging area. Where this density of hollow bearing trees is not available all hollow bearing trees within the net logging area must be retained.</p>		<p>FCNSW retained two hollow bearing trees per hectare in accordance with clause 5.6d (i) (Image 1).</p>

<p><b>Image 1.</b> Retained H tree, Transect 1, Plot 1.</p>		
<p><b>CONDITIONS RELATED TO HOLLOW BEARING TREE SELECTION</b></p>				
<p><u>Clause 5.6 tree retention</u></p> <p>Clauses 5.6d (ii) &amp; (iii) &amp; 5.6e Regrowth zone hollow-bearing tree selection</p> <p><i>In selecting hollow bearing trees for retention, priority must be given to any hollow-bearing trees which exhibit evidence of occupancy by hollow dependent fauna and trees which contain multiple hollows or hollows of various sizes.</i></p> <p><i>Hollow-bearing trees must be selected with the objective of</i></p>	<p><b>Yes</b></p>	<p>The EPA finds FCNSW compliant with clause 5.6d (ii) &amp; (iii) regrowth zone hollow-bearing tree selection.</p> <p><u>Hollow bearing tree selection</u></p> <p>The two trees selected and marked as hollow bearing (H) trees meet the licence conditions for hollow bearing tree selection, as the trees:</p> <ul style="list-style-type: none"> <li>• had visible hollows, holes or cavities</li> <li>• were of the largest diameter cohort of trees</li> <li>• had good crown development</li> <li>• had minimal butt damage</li> <li>• were evenly scattered throughout the net harvest area</li> </ul>	<p>0 (2) 2 trees in 1ha assessed area</p>

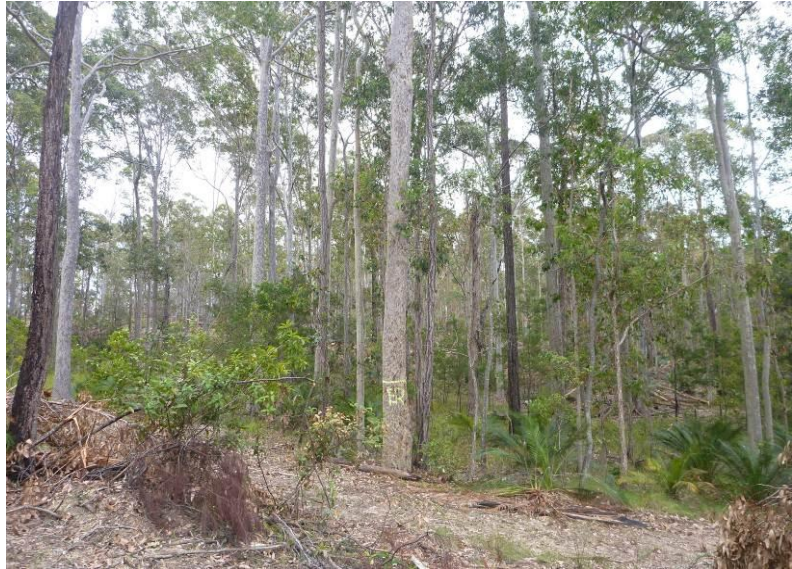
<p>retaining trees having as many of the following characteristics as possible:</p> <ul style="list-style-type: none"> <li>• belonging to a cohort of trees with the largest dbhob</li> <li>• good crown development</li> <li>• minimal butt damage</li> <li>• represent the range of hollow-bearing species that occur in the area.</li> <li>• located such that the result in retained trees being evenly scattered throughout the net logging area</li> </ul>				
<p align="center"><b>CONDITIONS RELATED TO RECRUITMENT TREE - RETENTION</b></p>				
<p><i>Clause 5.6 tree retention</i></p> <p><i>Clauses 5.6e Regrowth zone H&amp;R tree selection</i></p> <p><i>Within the regrowth zone, for each hollow bearing tree retained in (d) above a recruitment tree must be retained.</i></p>	<p><b>Yes</b></p>	<p><b>The EPA finds FCNSW compliant with clause 5.6e Regrowth zone tree retention.</b></p> <p>FCNSW retained two recruitment trees per hectare in accordance with clause 5.6e. For each hollow-bearing tree retained FCNSW retained a recruitment tree (Image 2). EPA did not obtain data on candidate R trees.</p>

<p><b>Image 2.</b> Selected, marked &amp; retained R tree, Transect 1, Plot 1.</p>	<p>0 (1) 1 ha assess area</p>

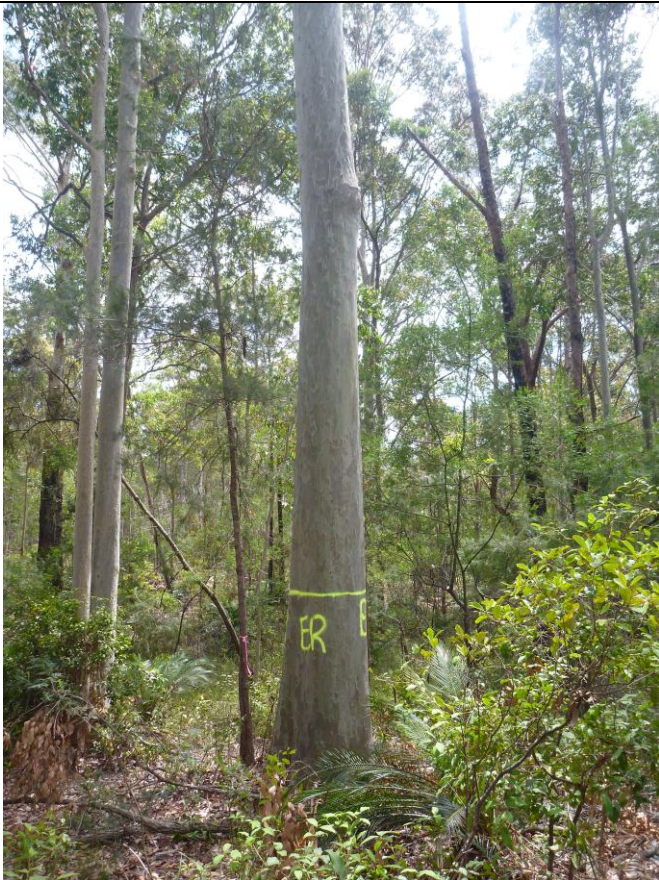
<p><b>Image 3.</b> Transect 2, Plot 1. Retained R tree, no logging debris at base of tree.</p>		
		Sub-total	0 (10)

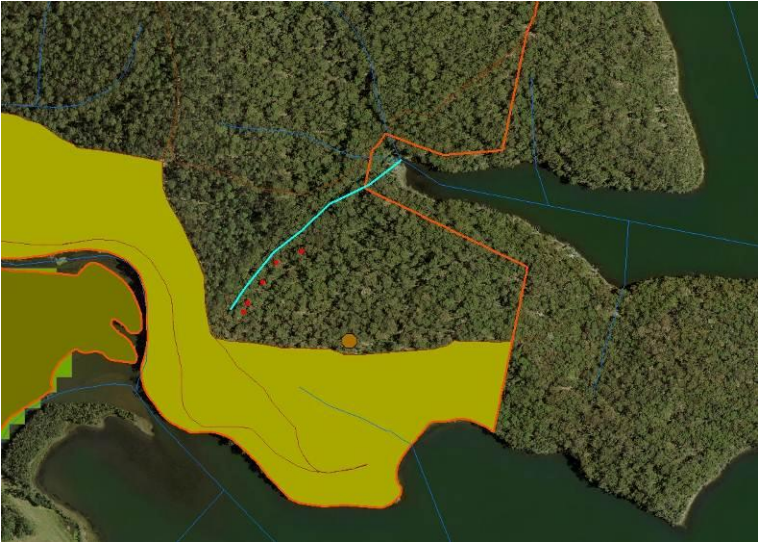
<p><i>D. Protection of drainage features</i></p>	<p><b>Yes</b></p>	<p><b>Transect 1, the EPA found FCNSW to be compliant with this condition at this location.</b></p> <p>EPA officers audited a 100m length along the unnamed first order drainage feature identified in image 6.</p> <p>EPA officers measured the distance from top of the bank of the incised channel to the boundary of the marked exclusion zone.</p> <p>It was observed that boundaries were clearly marked with flagging tape and had been observed by harvesting crews.</p>

<p><b>Image 6.</b> Location of Transect 1 drainage feature audit and location of audit measurement locations (red circles).</p> <p>The key audit findings are:</p> <ul style="list-style-type: none"> <li>• FCNSW correctly specified the filter strip and protection zone exclusions on the Harvest Plan Operational Map</li> <li>• FCNSW field staff correctly applied the exclusion zones in the field at all observed locations.</li> <li>• there were no incursions into the marked exclusion zone observed by EPA auditors</li> </ul> <p>FCNSW is compliant with clause 6 of the Southern Region IFOA as the protection of drainage feature measures have been correctly applied.</p>	<p>0 (1) 100m length assessed</p>

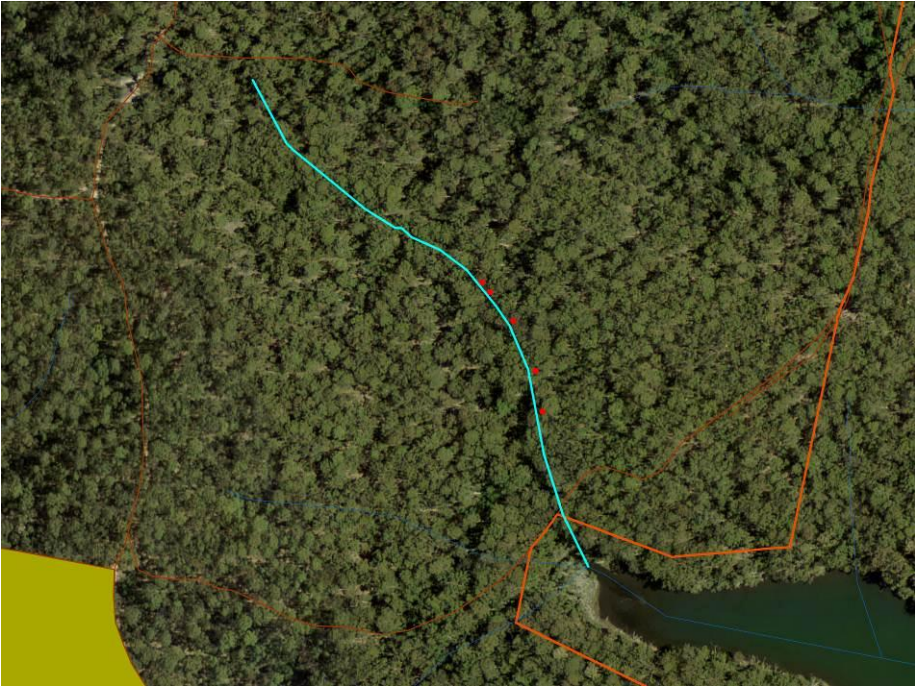
<p><i>D. Protection of drainage features</i></p>	<p>Not determined</p>	<p><b>Transect 2, the EPA recorded an audit finding of not determined with this condition at this location.</b></p> <p>EPA officers audited a 100m transect along the unnamed first order drainage feature identified in Image 7.</p> <p>EPA officers measured the distance from top of the bank of the incised channel to the boundary of the marked exclusion zone (Images 8 to 9).</p> <p>It was observed that boundaries were clearly marked with flagging tape and had been observed by harvesting crews.</p>

<p><b>Image 7.</b> Location of Transect 2 drainage feature audit and approximate location of audit measurement locations (red circles).</p> <p>The key audit findings are:</p> <ul style="list-style-type: none"> <li>From the audit evidence gathered it remains not determined whether there was an incursion into the protection zone by FCNSW contractors.</li> <li>FCNSW correctly specified the filter strip and protection zone</li> </ul>	<p>N/A 100m length assessed</p>	<p>N/A</p>

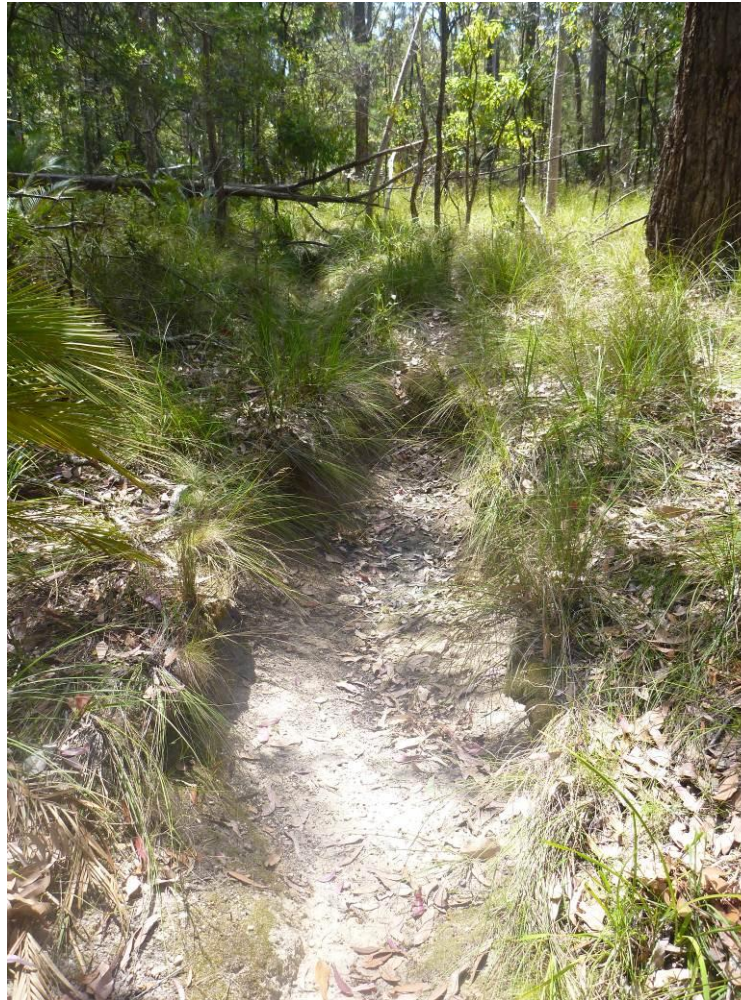
- FCNSW field staff incorrectly applied the protection zone boundary in the field at one observed location.

**Image 8.** Drainage feature with incised channel within drainage feature transect 2.

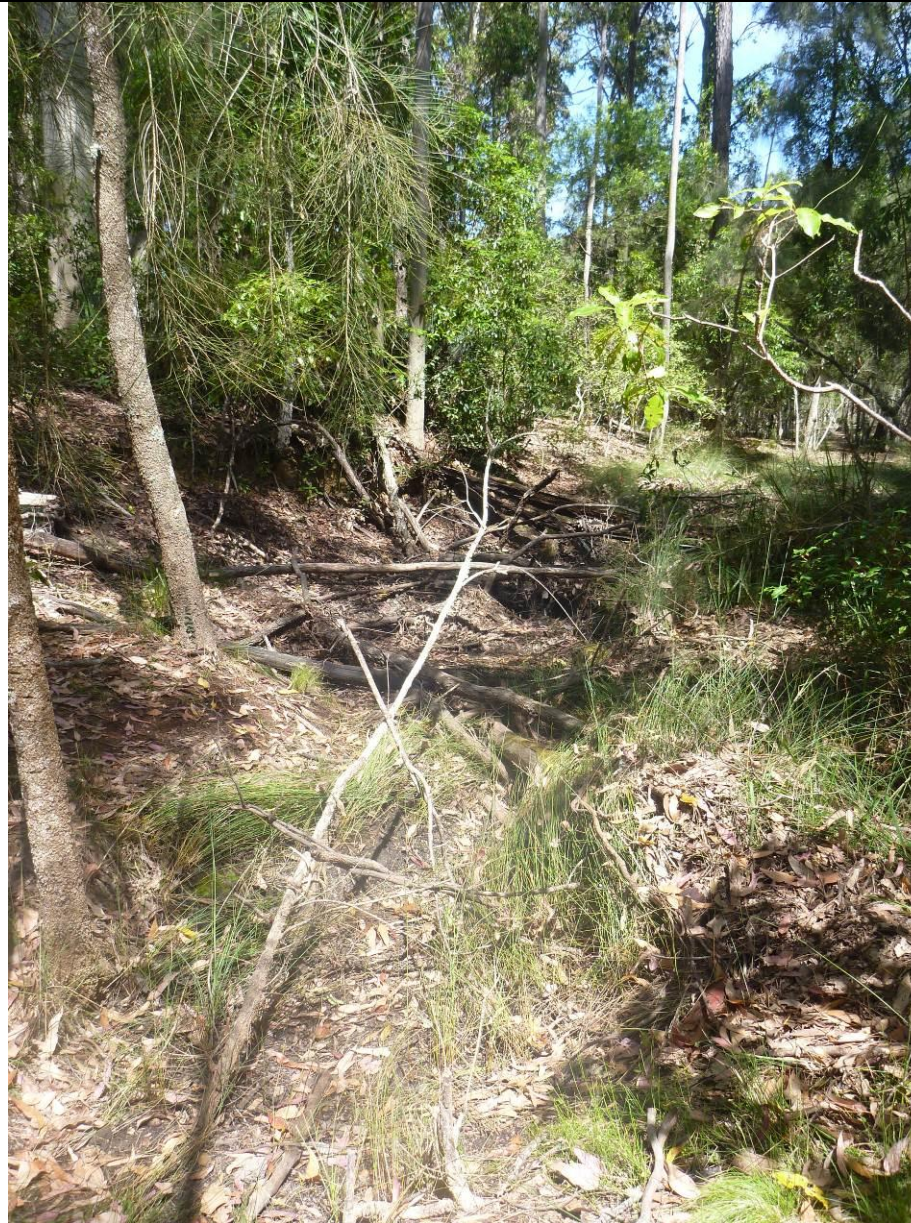
**Image 9.** Drainage feature at approximately 100m along transect 2.

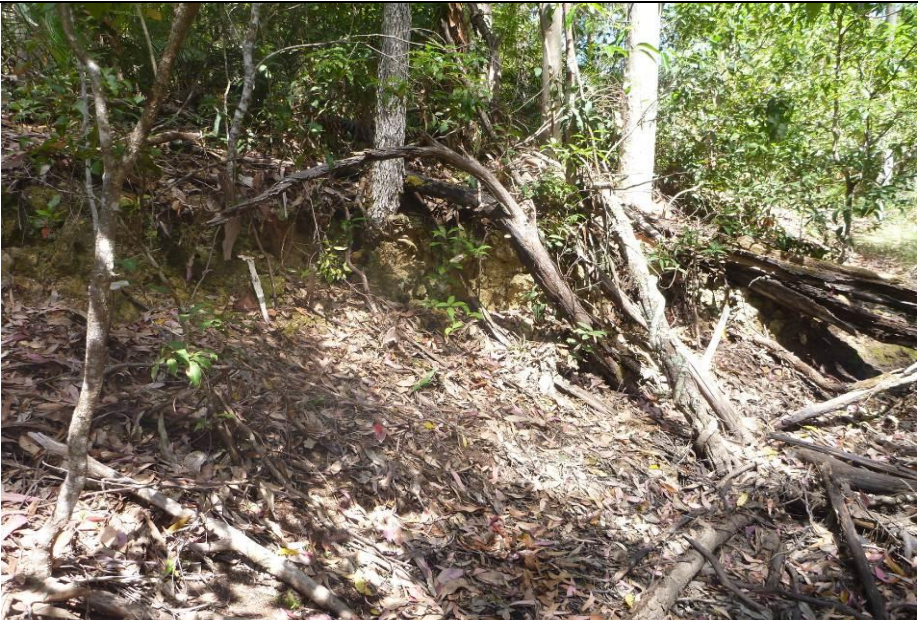
<p><b>Image 10.</b> Drainage feature blow out or gully at location 5, 100m along transect 2. Note: measured buffer (5 m filter strip plus 5 m protection strip) was only 5m at this location due to the gully not being observed at mark-up. As the distance from the mark up to the edge of the harvesting operation was not measured it is not possible to make a determination regarding compliance with condition D drainage feature protection.</p> <p><b>Why it is important?</b> The protection of drainage features is important for a number of environmental reasons. These include:</p> <ul style="list-style-type: none"> <li>• reducing the potential for water pollution, protection of threatened species and their habitat benefits overall biodiversity, used as riparian corridors for all species and protects the terrestrial ecosystem that supports the aquatic environment.</li> <li>• specifically protected drainage features in the Southern Region IFOA area provide pathways and linkages for fauna and flora to move across the landscape. It has high significance in regards to biodiversity such as providing habitat for a range of fauna.</li> <li>• correctly marking boundaries in the field is important to inform operators on the ground of the areas they need to protect and prevent actual harm.</li> </ul>

eucalypt feed trees.
IFOA clause 6 / Pg 12	Protection of drainage features	South of log dump 8	<p>FCNSW inspected this location and observed boundary marking consistent with EPA draft audit findings.</p> <p>However, the draft audit report identifies that a non-compliance with IFOA clause 6 has occurred. IFOA clause 6 sets out the terms of the licences, in this case the TSL and EPL. There is no requirement to mark drainage feature protection in the field under condition 5.7 of the TSL or EPL sched. 4 condition D. These conditions only require FCNSW to ensure protection zones and filter strips are implemented during specified forestry activities. FCNSW field observations found that at this location all specified forestry activities had been conducted in accordance with the EPL and TSL – drainage feature protection measures have been correctly implemented.</p> <p>FCNSW requests that the EPA amend its compliance finding to “not determined” in the final audit report.</p>	Addition of a “Further observation”	<p>The EPA considered FCNSW submissions and field evidence gathered.</p> <p>There is no requirement in the Southern Region IFOA or TSL to mark the boundaries of riparian protection zones.</p> <p>The licence requires only that FCNSW protect zone filter strips.</p> <p>In this instance, field marking to inform harvesting crews of exclusion zone boundaries was done but incorrect.</p> <p>Marking exclusion zone boundaries in the field is considered good practice.</p> <p>EPA staff measured the distance from the marked boundary to the drainage feature but not from the edge of the harvesting operation to the drainage feature. The EPA amends its draft finding and makes it’s field observation as a <b>“Further observation”</b></p>

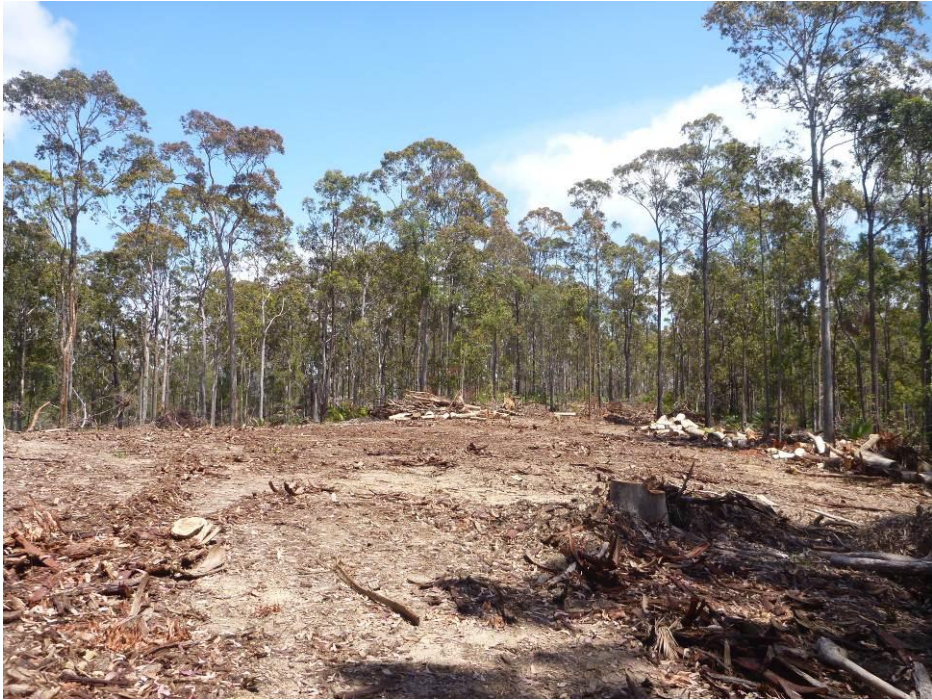
Relevant Condition	Details of matter	Recommendation
<p><a href="#">Appendix A</a> <a href="#">Schedule 4A</a> <a href="#">Clause F</a></p> <p><i>Log Dumps Runoff from log dumps must not be discharged into drainage features</i></p>	<p>Log dumps 12 and 13 were combined and moved to a new location (refer Image1). The size of the log dump appears to be excessive given the identified low volume of timber extracted from the compartment (Image 9).</p>

<p><b>Image 11.</b> Log dump 12, Compartment 3010 Bodalla State Forest.</p> <p>Excessively large log dumps are a potential source of water pollution from run off associated with large areas of exposed soil and result in the unnecessary removal of trees and groundcover.</p>	<p>Keep log dump size to the minimum size required to stockpile and sort logs by product whilst maintaining a safe working environment.</p>

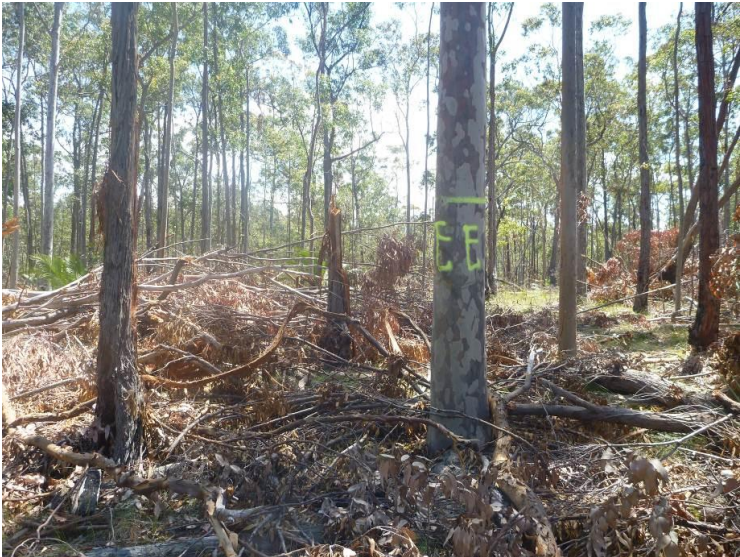
Relevant Condition	Details of matter	Recommendation
<p><a href="#">Clause 5.6 tree retention</a></p> <p><i>Clause 5.6h Protection of retained trees</i></p> <p><i>iii. When conducting specified forestry activities and post-logging burning, damage to trees retained under conditions 5.6 a), 5.6 b), 5.6 c), 5.6 d), 5.6 e) and 5.6 f) of this licence must be minimised to the greatest extent practicable. During harvesting operations, the potential for damage to these trees must be minimised by utilising techniques of directional felling.</i></p> <p><i>iv. In the course of conducting specified forestry activities,</i></p>	<p>EPA officers made further observation against this criteria for trees not within the scope of this audit that were retained against clause 5.6 (h) of the Southern Region IFOA.</p> <ul style="list-style-type: none"> <li>Logging debris must not, to the greatest extent practicable, be allowed to accumulate within five metres of a retained hollow bearing tree, recruitment tree, stag, <i>Allocasuarina</i> with more than 30 crushed cones beneath, <b>eucalypt feed tree</b>, or yellow bellied glider or squirrel glider sap feed tree.</li> <li>Logging debris within a 5 metre radius of retained trees must be removed or flattened to a height of less than one metre.</li> </ul> <p>20 live standing trees were retained across both transects and three retained trees were identified as having logging debris within 5 metres and up to 1 metre high fully or partially surrounding them (Images 3 to 5).</p> <p>One retained tree (feed tree) was identified as being retained for the purposes of clause 5.6h (Image 3). An attempt had been made to reduce the height of the logging debris to under one metre but this did not extend the full 5 metre width as required under Clause 5.6h.</p>

<p><b>Image 3.</b> Transect 2, Plot 1. Logging debris at base of tree within 5 metres and over 1m in</p>	<p><b>Non-compliant</b></p> <p><b>Code Yellow</b></p>

<b>Condition / Audit finding reference / page No.</b>	<b>EPA draft finding / risk category</b>	<b>Location – description GPS</b>	<b>FCNSW evidence submission</b>	<b>EPA final finding / risk category</b>	<b>EPA response to FCNSW submission</b>
TSL 5.6(h) / Pg 5	Protection of retained trees / Not Compliant Yellow	Unknown – no location information provided by EPA	<p>FCNSW has reviewed the draft audit findings.</p> <p>It is unclear from the audits findings how FCNSW has breached condition 5.6 (h). Condition TSL Condition 5.6 (h) (iii) requires that retained trees must be marked. Consequently any trees not marked are not considered retained trees under condition 5.6, thus conditions 5.6 (h) (i) &amp; 5.6 (h) (ii) does not apply to unmarked trees. Furthermore the marked “E” identified in image 3 is a tree retained under condition 6.5 of the TSL – condition 5.6 (h) is not applicable in this instance.</p> <p>FCNSW requests that the EPA remove this audit finding from the final audit report.</p>	<p>Compliant</p> <p>EPA changed its audit finding from “Not compliant” to “Compliant”</p>	<p>The EPA considered FCNSW submissions and field evidence gathered.</p> <p>The scope of the audit was restricted to H&amp;R trees. All H&amp;R trees observed in the area assessed were protected according to Condition 5.6.(h) of the TSL.</p> <p>The EPA amends its draft audit finding from not compliant code Yellow to Compliant.</p>

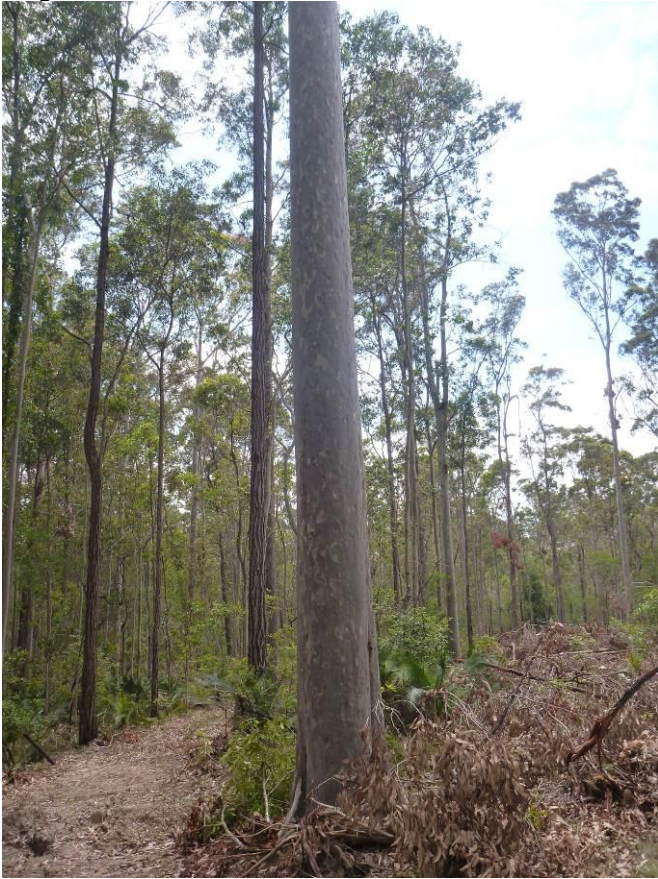
<p><b>Image 4.</b> Transect 1, Plot 1. Logging debris at base of tree within 5 metres and over 1m in height.</p>

Relevant Condition	Details of matter	Recommendation
	<p>The EPA determined that the risk of environmental harm has been assessed as Code Yellow because:</p> <ul style="list-style-type: none"> <li>• environmental harm is likely to occur during the post logging burn due to logging debris accumulation, and</li> <li>• the level of environmental impact is low as the scale of harm is likely to be low.</li> </ul> <p><b>Why is this important?</b></p> <p>The EPA considers the protection of all retained trees to be important because the maintenance of biodiversity, forest health and the productive capacity of these forest ecosystems is vital for the long term sustainability of the forest.</p> <p>Further damage to retained trees can be a vector for disease and fungal attacks. Failing to protect all retained trees following a successful harvesting event can lead to long term decline in forest health.</p> <p>Regrowth forests contain few large trees that can support hollow dwelling species. The long term maintenance of retained trees is vital for the development of a multi age class forest.</p>

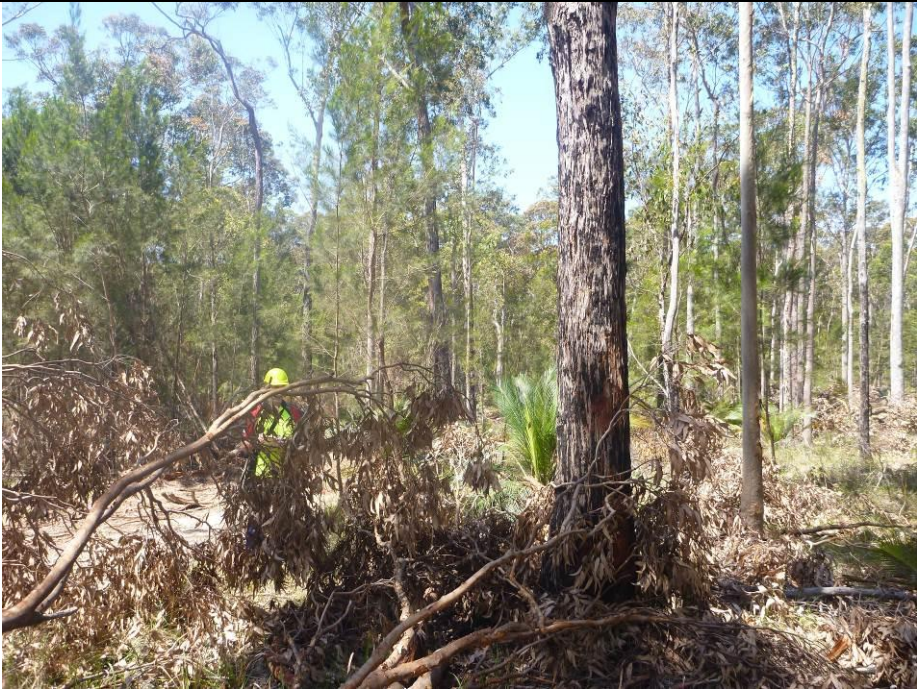
<p><b>Image 5.</b> Transect 2, Plot 3. Logging debris at base of tree within 5 metres and over 1m in height.</p> <p><b>Risk assessment of non-compliance</b></p> <p>The EPA has made a risk assessment of tree protection in the assessed area. These were assessed against two criteria:</p> <ul style="list-style-type: none"> <li>• the likelihood of environmental harm occurring; and</li> <li>• the level of environmental impact.</li> </ul> <p>These results were used to decide the level of risk to retained trees. The risk assessment noted:</p> <ul style="list-style-type: none"> <li>• the accumulation of logging debris greater than 1 metre in height and within 5 metres of retained trees;</li> </ul>
