Preliminary Surface Water Investigation Results – Williamtown NSW

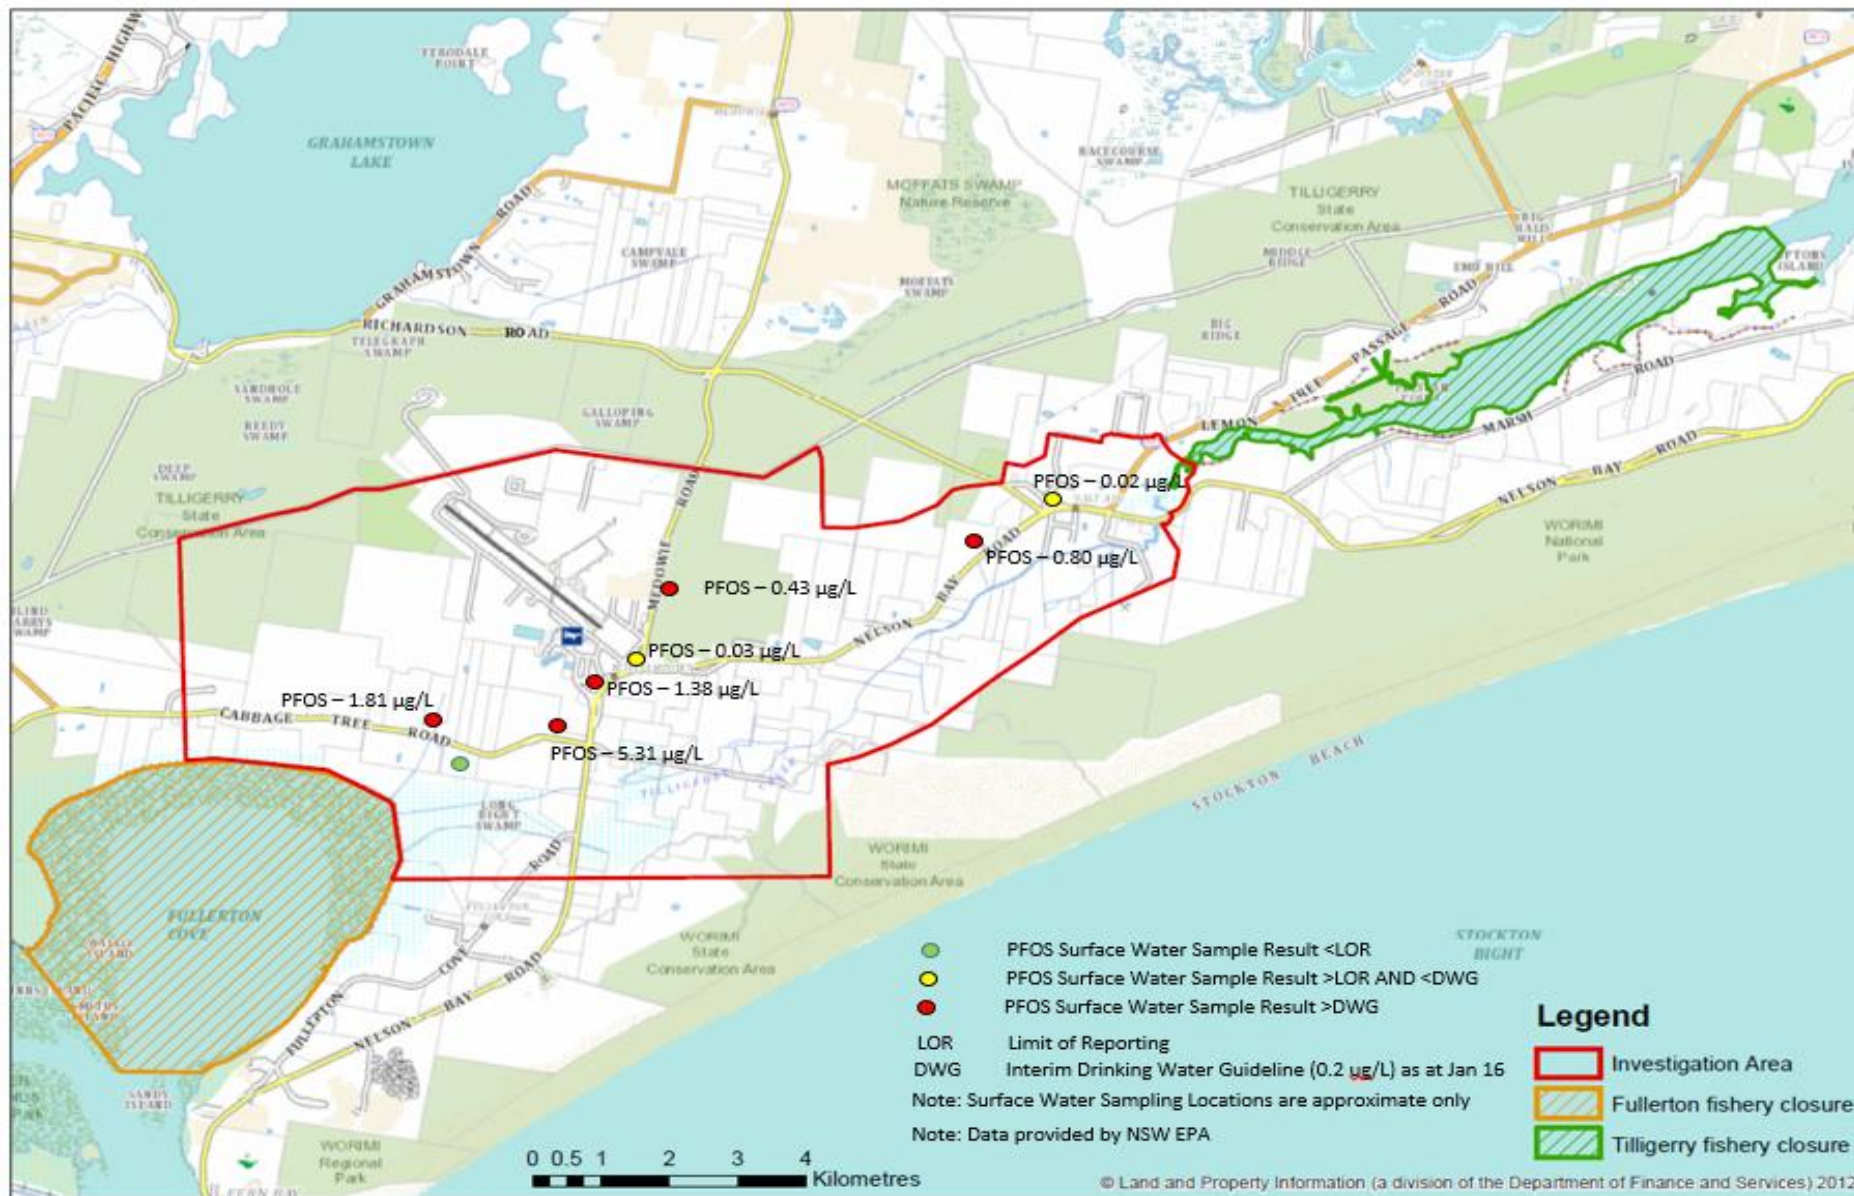
Surface Water – PFOS Analytical Results– Jan 2016 (Post Flood)

PFAS were detected in most samples, including standing water on public property and ditches. Post-flood PFAS concentrations were consistent with pre-flood measurements in the same area.

A summary of the EPA Surface Water Sampling Data is provided in the accompanying map.

The results were also consistent with the health advisory, which includes not to drink or prepare food from water bores, drains, creeks or dams inside the Investigation Area.
