East Coast Flood Project: executive summary

Water quality monitoring program

Department of Climate Change,
Energy, the Environment and Water

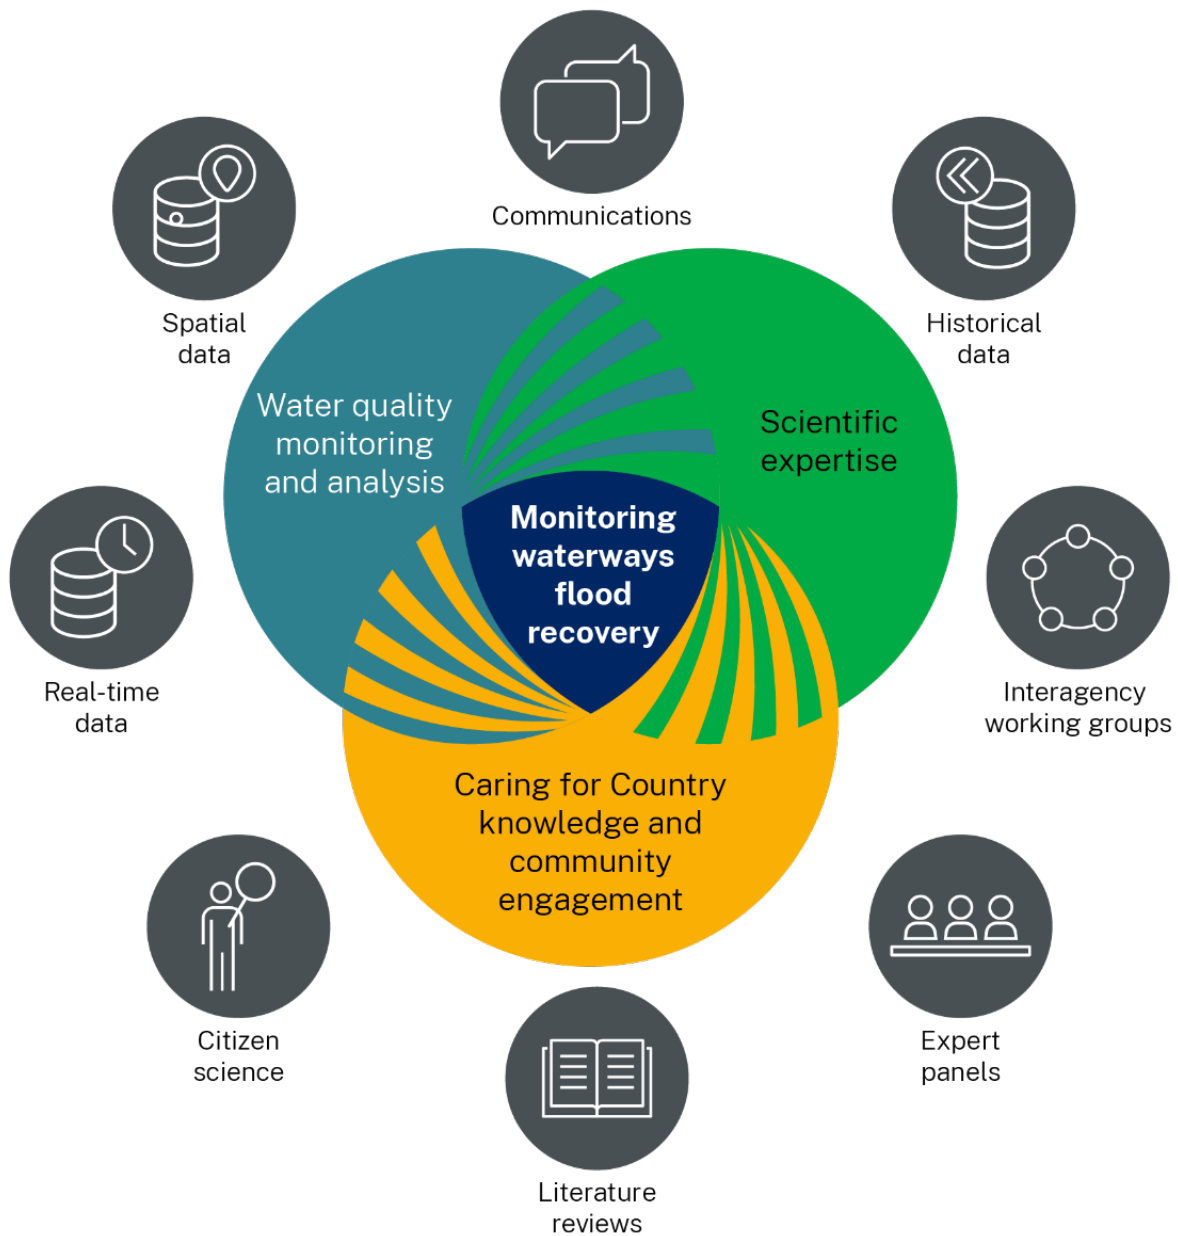
Figure 1 Delivery framework for the flood recovery program for water quality monitoring – East Coast Flood Project

To meet project aims and objectives, a multifaceted project was delivered, built on scientific knowledge, engagement with local and traditional knowledge, and development and delivery of a robust and comprehensive monitoring program that targeted knowledge and data gaps for flood-affected regions (Figure 1).

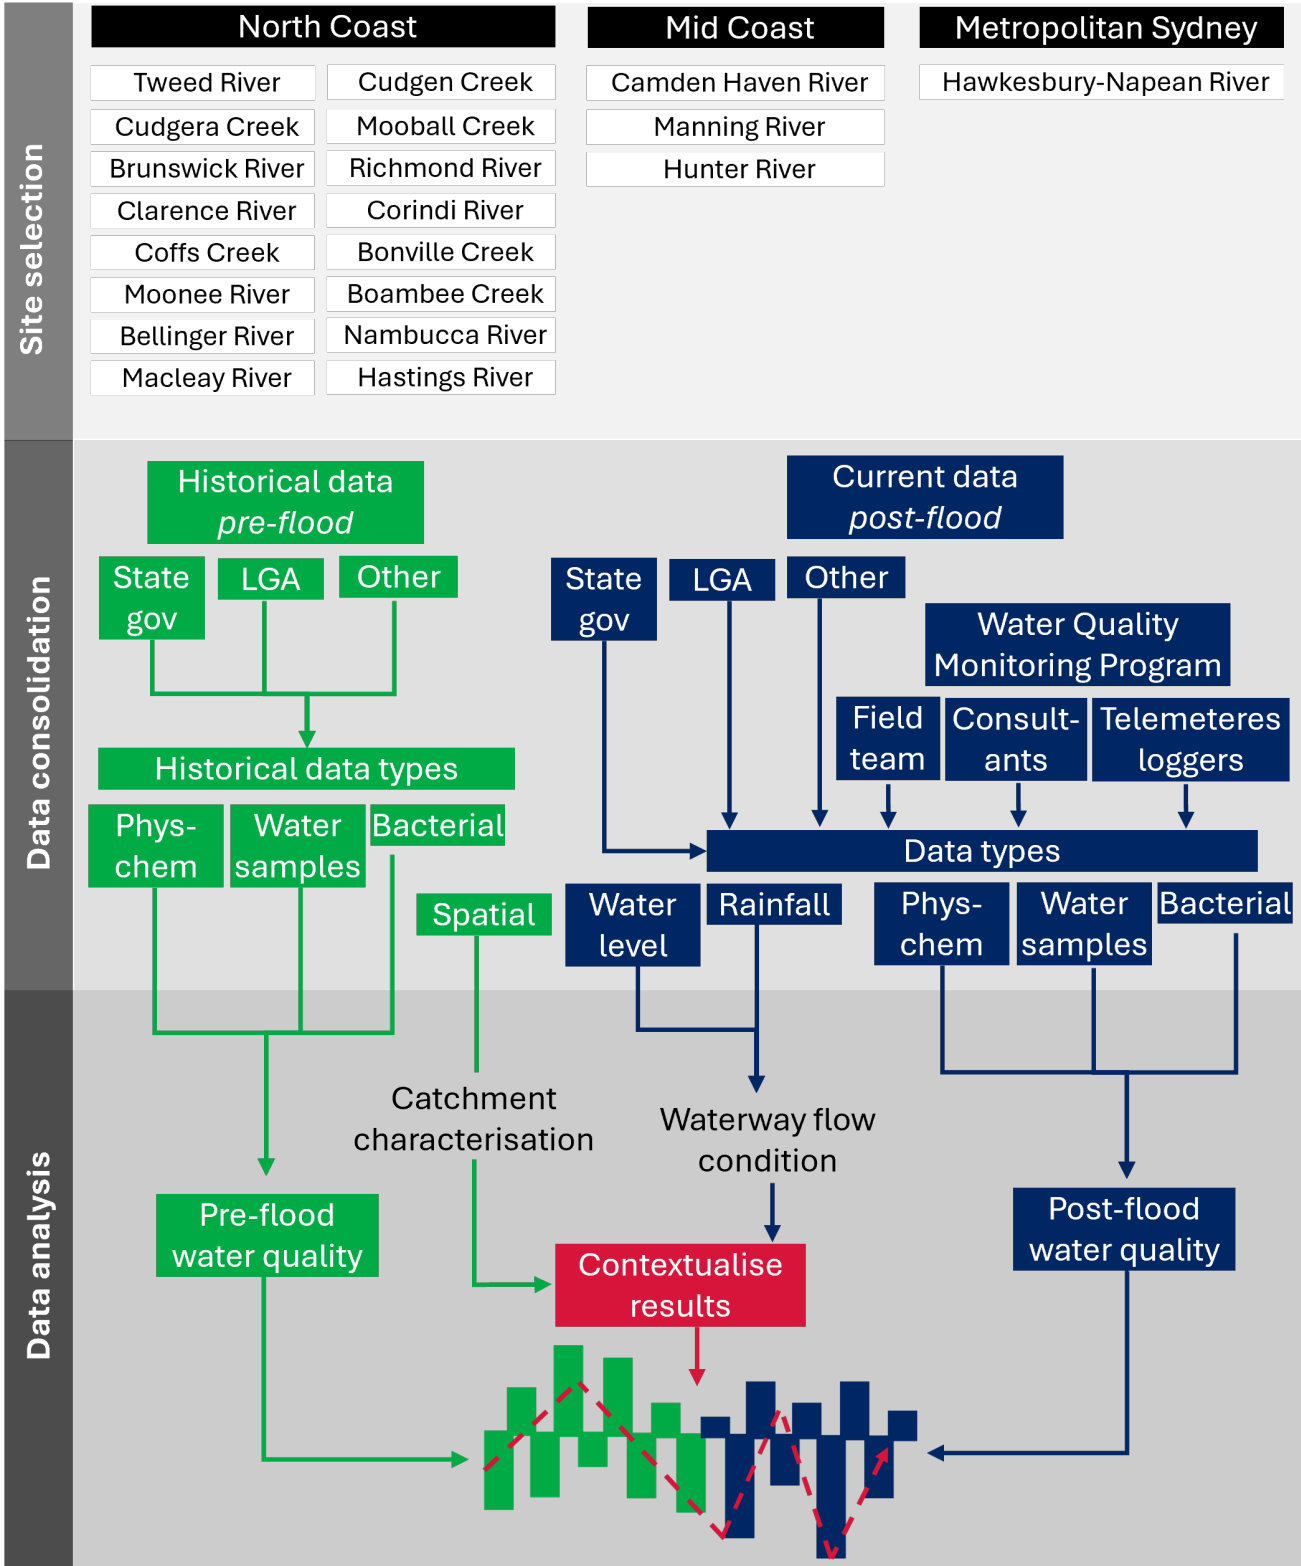
Figure 5 Project sampling design and implementation. Phys-chem = physicochemical parameters (see Table 2)

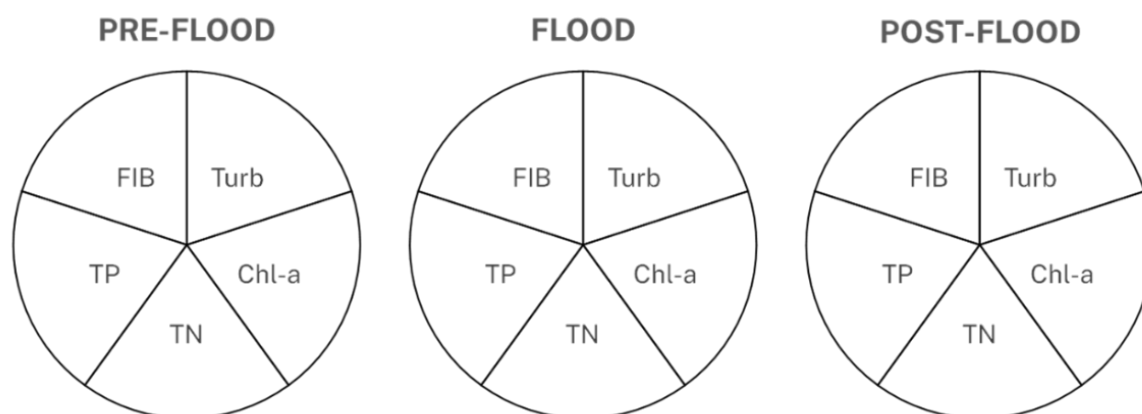
Figure 7 Water quality grade key presenting guideline value exceedances (%) for turbidity (Turb), chlorophyll-a (Chl-a), total nitrogen (TN), total phosphorous (TP) and the faecal indicator bacteria (FIB) – enterococci before (pre-flood), during flood and post flood

The water quality grades were presented using a series of colour wheels to enable the comparison of water quality for individual parameters before (pre-flood), during (flood) and after the 2022 flood events (post-flood) (Figure 6). Grades were only presented for waterways and parameters that met the minimum requirements of grading – being sufficient spatial and temporal replication for the size of the waterway, and the availability of individual grades for all key parameters.

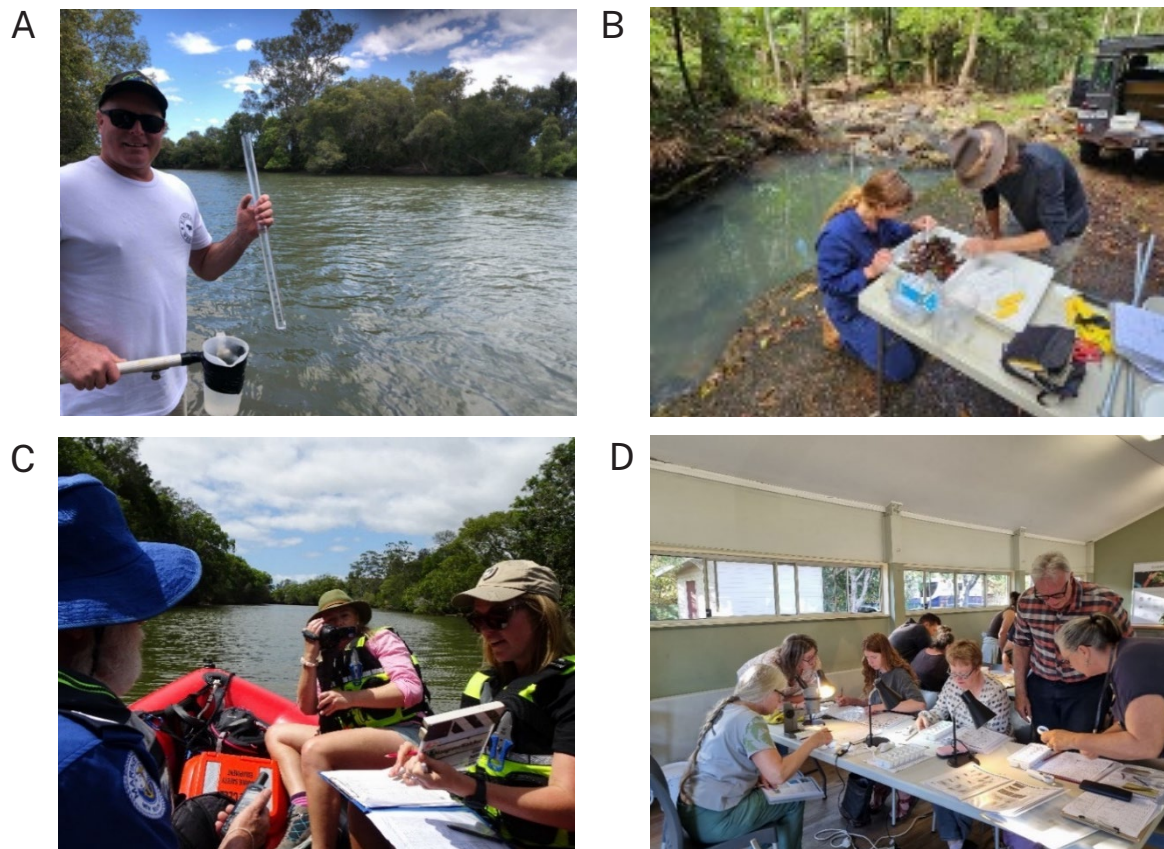
Figure 8 The Citizen Science Partnerships Program. A. An OzFish volunteer tests water clarity in the Clarence using a turbidity tube (OzFish). B. Richmond Riverkeeper volunteers sort macroinvertebrates at a site on the Richmond River (Richmond Riverkeepers Association). C. Positive Change for Marine Life volunteers conduct a shoreline video assessment of mangrove habitat on the Brunswick River (Positive Change for Marine Life). D. OzGREEN volunteers sort and identify macroinvertebrates during the Bellingen Riverwatch Macro Muster 5 (DCCEEW)

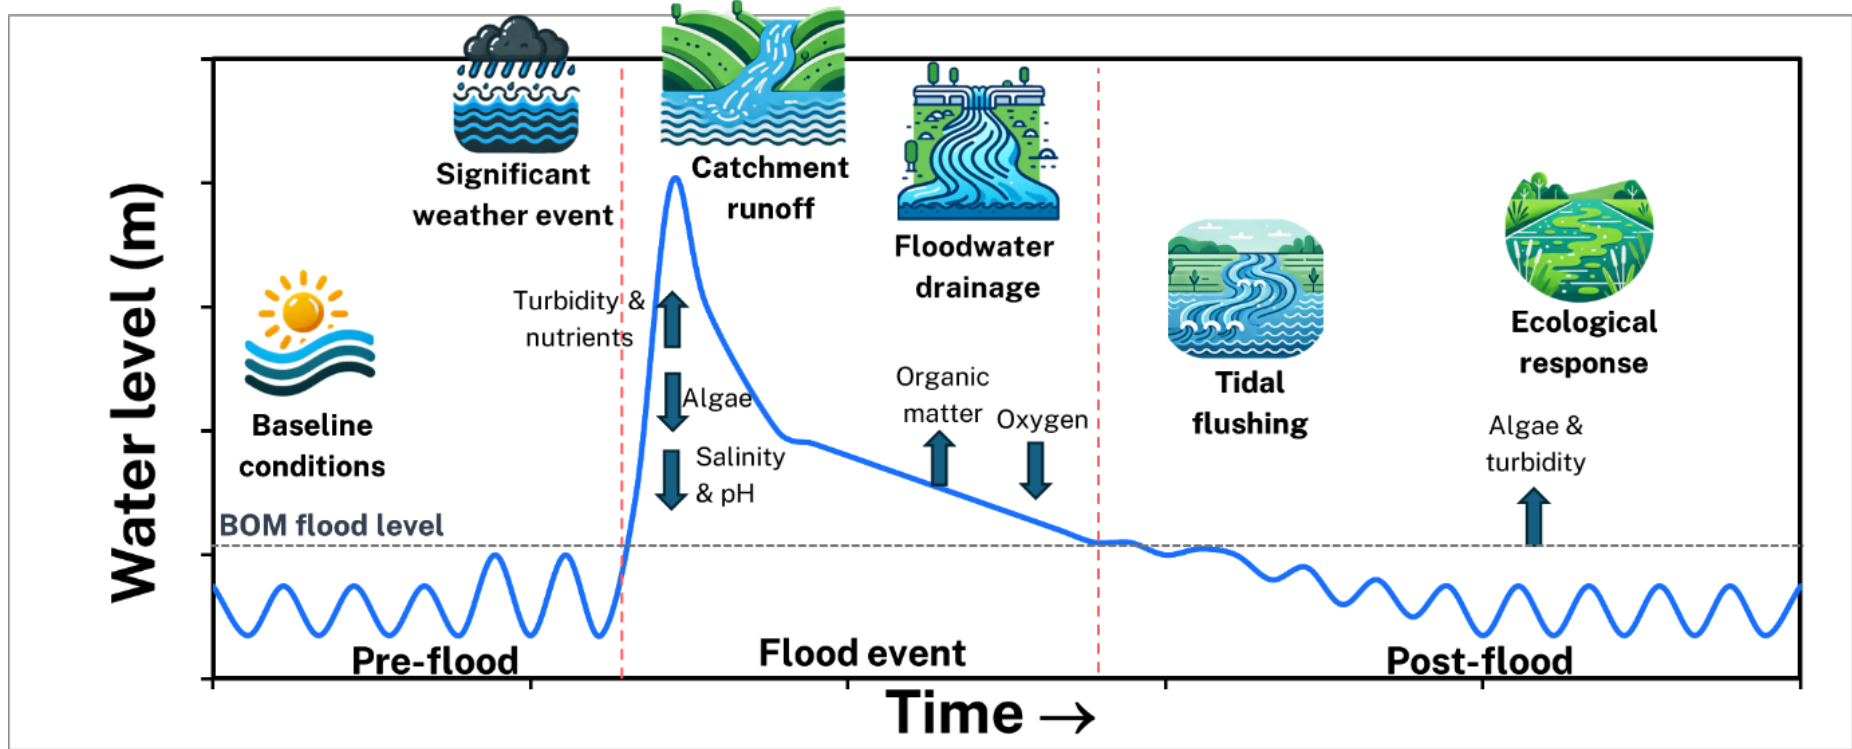
Figure 10 A conceptual diagram displaying the succession of impacts and recovery for water quality parameters during the floods on the NSW east coast is based on the data and observations made through the project

Following recession of flood waters to baseline water level, the first parameters to recover were turbidity and nutrients, and salinity for estuaries.

For estuarine sites, recovery is initiated by tidal flushing, which drives the return of the tidal signature and semi-diurnal tides, leading to recovery of salinity levels and the reestablishment of estuarine zones. In the short-term post-flood (days to weeks), flushing by marine waters leads to improved water clarity and increased sunlight penetration.

In the longer-term post-flood (weeks to months), chlorophyll-a levels increase due to increased photosynthetic activity, resulting in increased turbidity levels. Recovery from the 2022 floods varied across waterways, depending on their catchment characteristics, land uses and pre-flood condition.

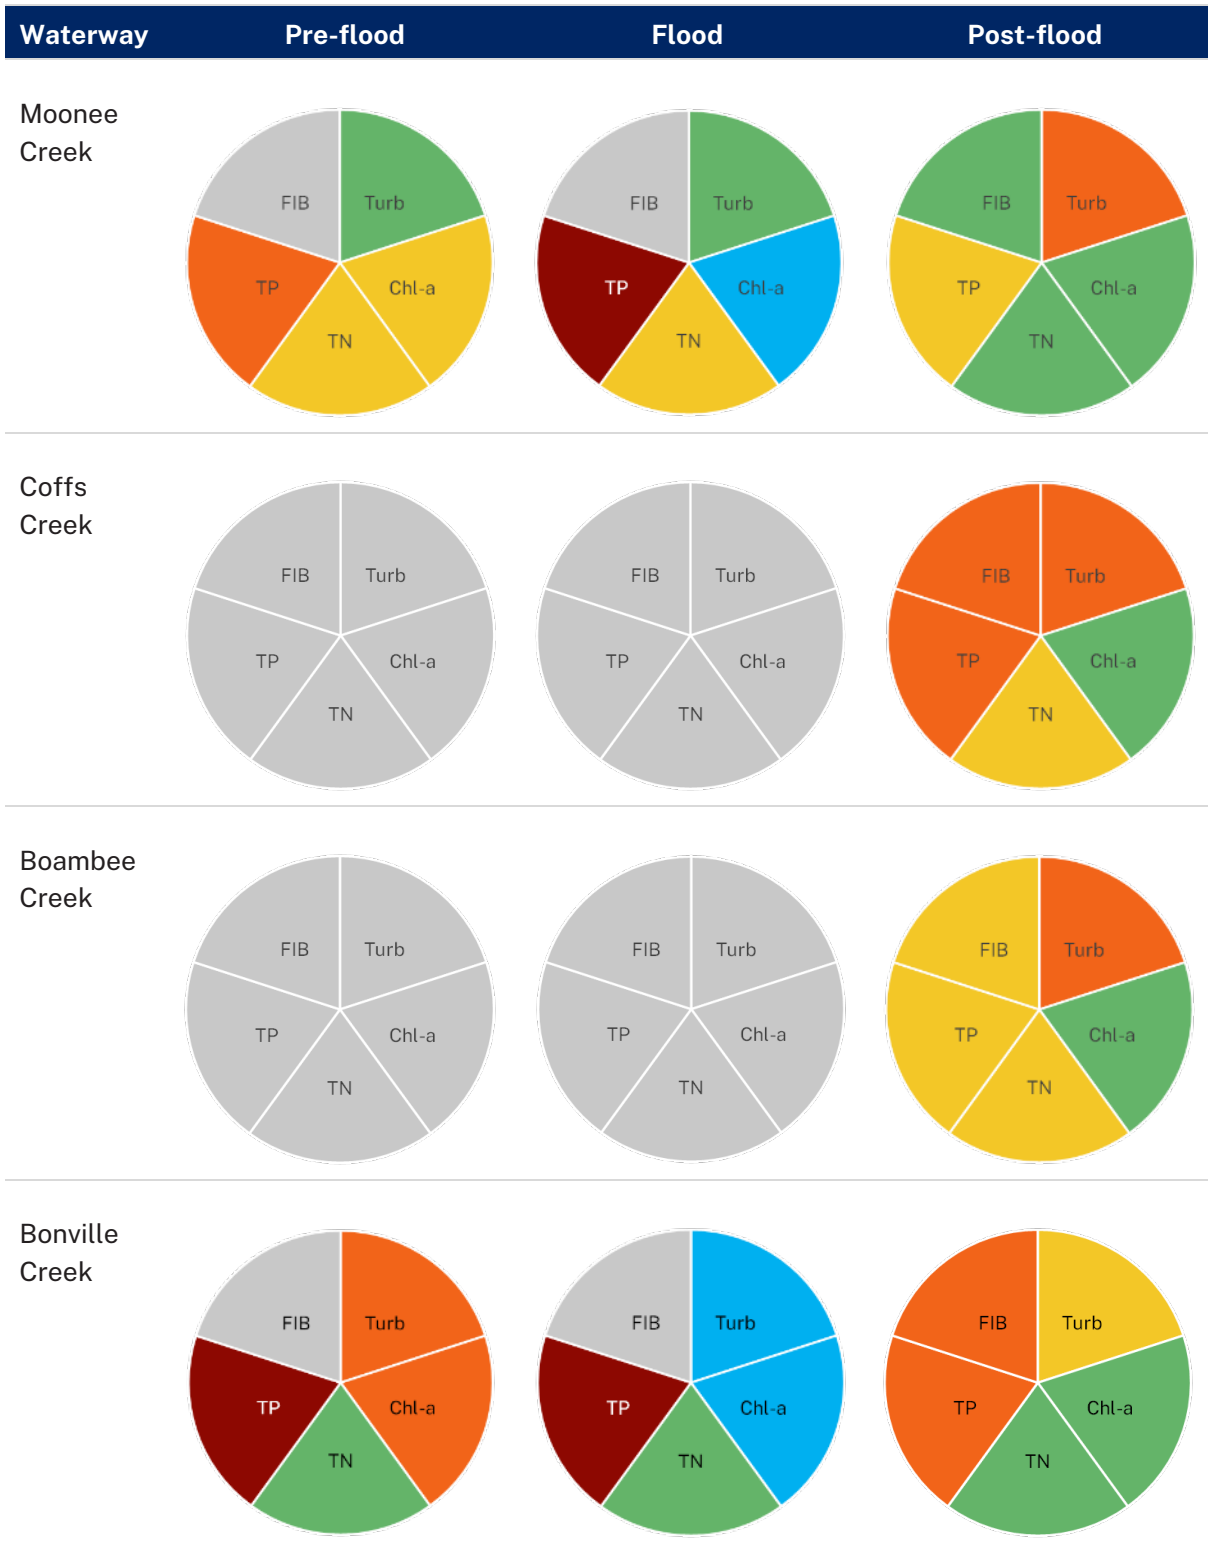
Table 6 Summary of water quality grades for key indicators of water quality across flood-impacted north coast waterways in the project before (pre-flood), during (flood) and after (post-flood) the 2022 disaster declared flood events. Turb = turbidity, Chl-a = chlorophyll-a, TN = total nitrogen, TP = total phosphorous and FIB = enterococci. Colours indicate: ■ Very good (≤ 0.00 , 0%), ■ Good (0-25%, 0-25%), ■ Fair (≤ 0.5 , 25-50%), ■ Poor (≤ 0.75 , 50-75%), ■ Very Poor (≤ 1 , 75+%)

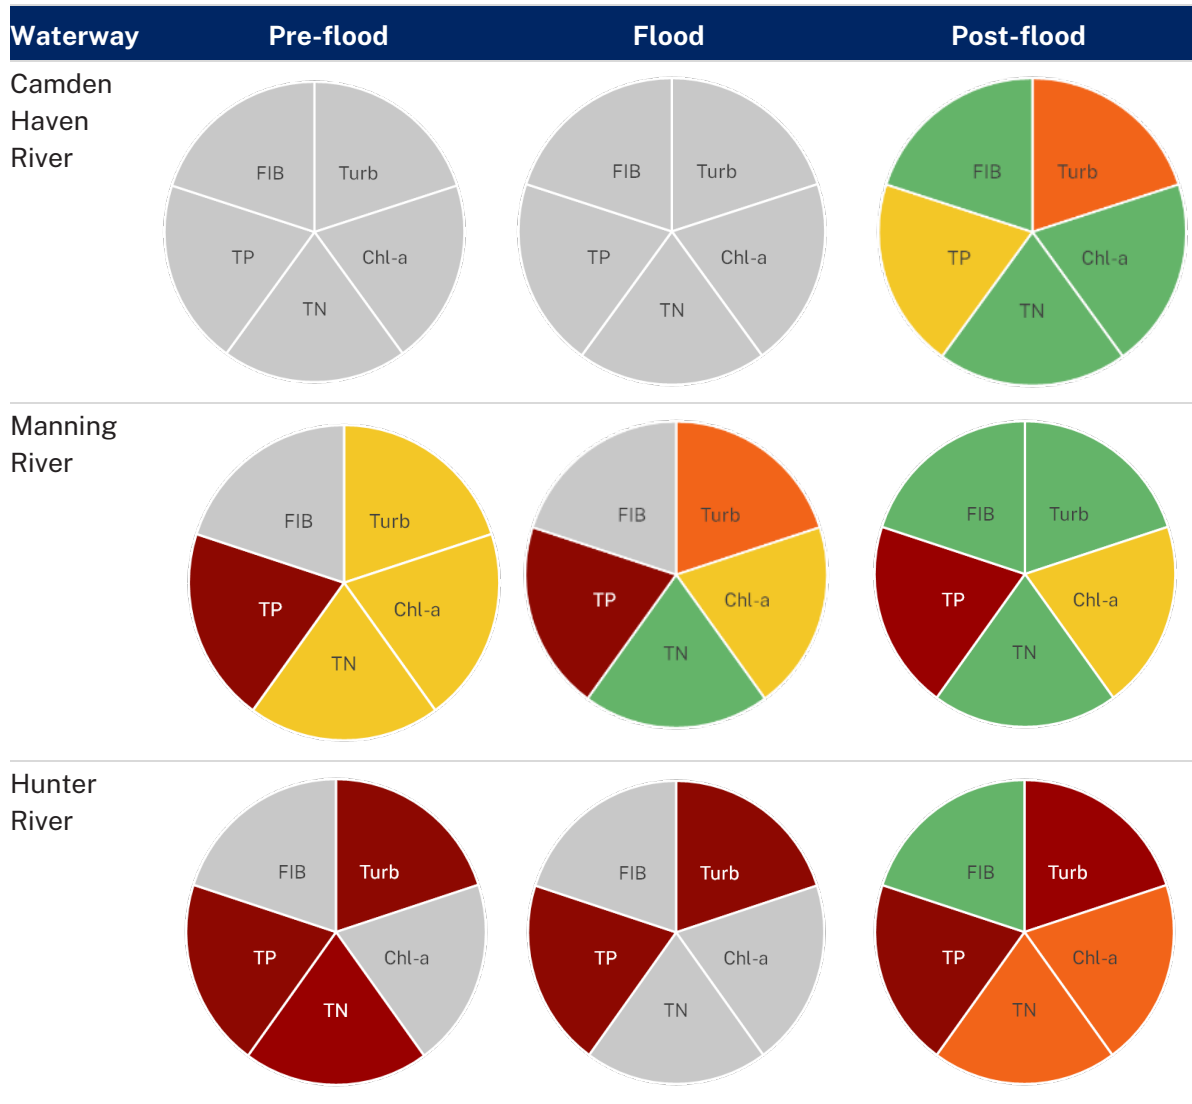
Table 7 Summary of water quality grades for key indicators of water quality across flood-impacted mid-coast waterways in the project before (pre-flood), during (flood) and after (post-flood) the 2022 disaster declared flood events. Turb = turbidity, Chl-a = chlorophyll-a, TN = total nitrogen, TP = total phosphorous and FIB = enterococci. Colours indicate: ■ Very good (≤ 0.00 , 0%), ■ Good (0-25%, 0-25%), ■ Fair (≤ 0.5 , 25-50%), ■ Poor (≤ 0.75 , 50-75%), ■ Very Poor (≤ 1 , 75+%)

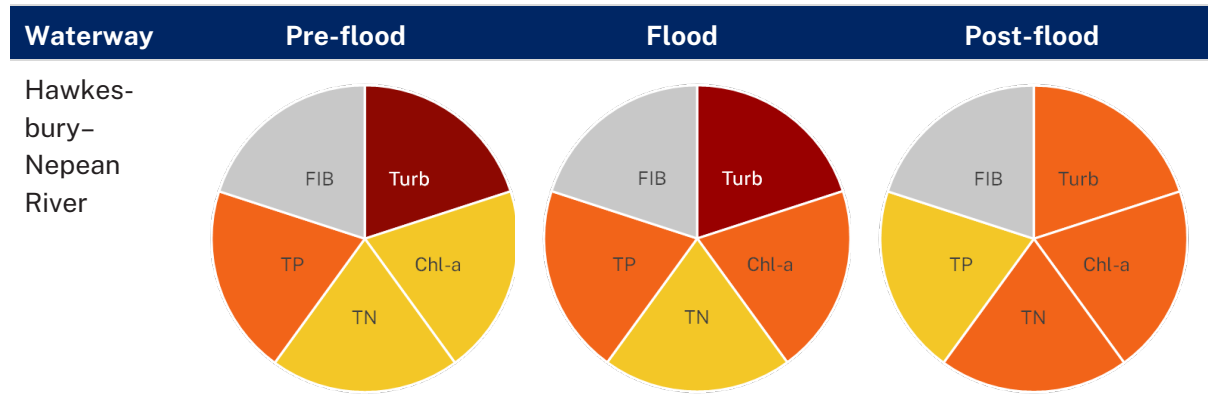
Table 8 Summary of water quality grades for key indicators of water quality across flood-impacted waterways in the Hawkesbury-Nepean River (pre-flood), during (flood) and after (post-flood) the 2022 disaster declared flood events. Turb = turbidity, Chl-a = chlorophyll-a, TN = total nitrogen, TP = total phosphorous and FIB = enterococci. Colours indicate: ■ Very good (≤ 0.00 , 0%), ■ Good (0-25%, 0-25%), ■ Fair (≤ 0.5 , 25-50%), ■ Poor (≤ 0.75 , 50-75%), ■ Very Poor (≤ 1 , 75+%)

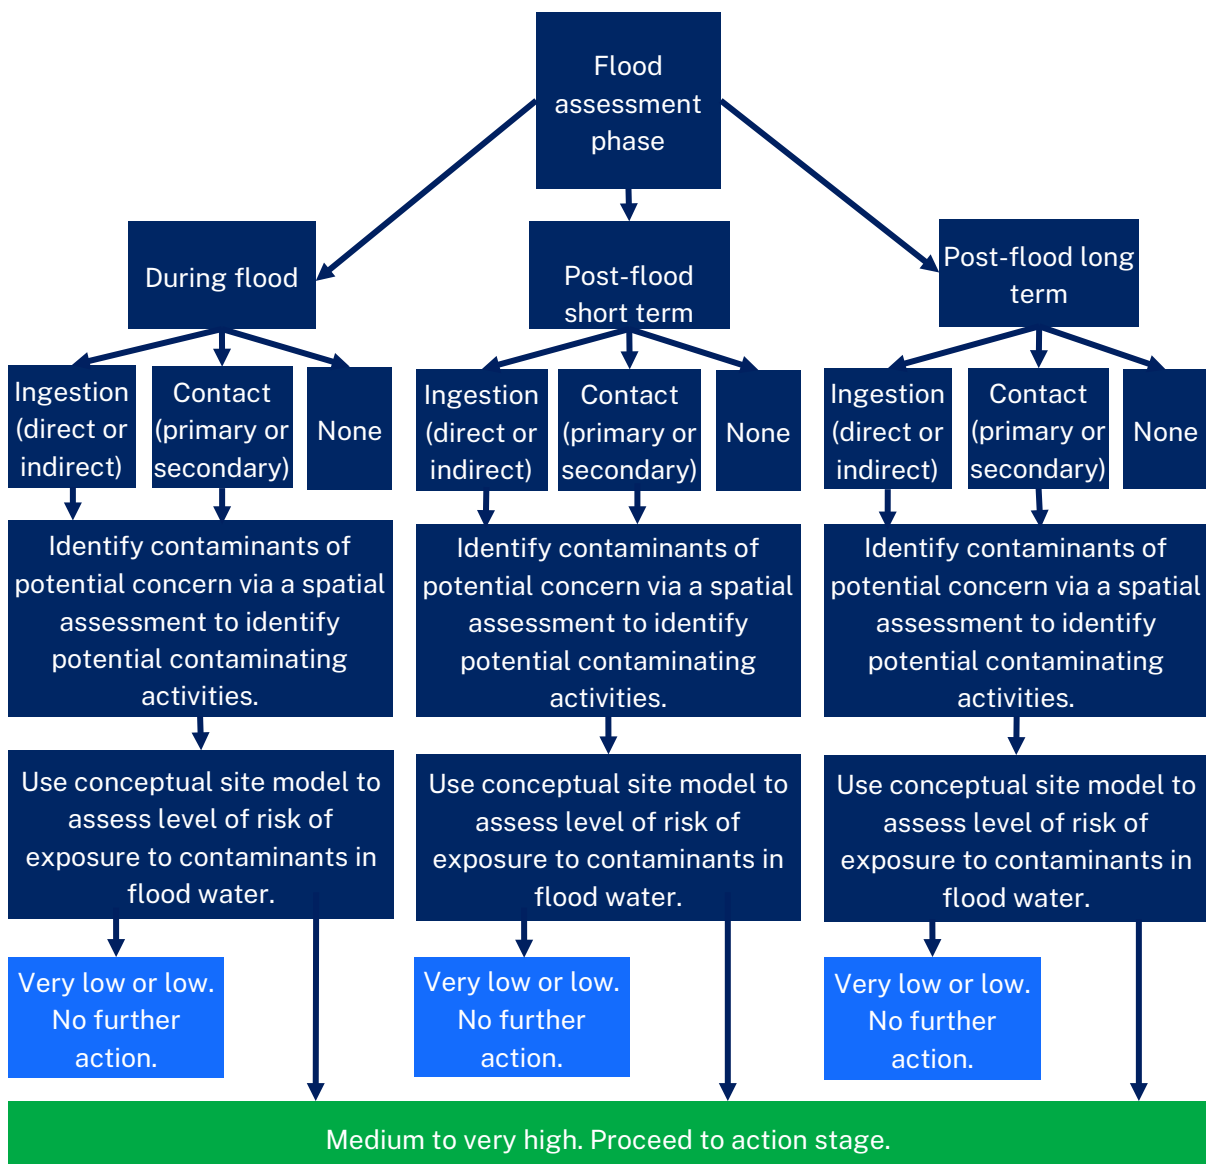
Figure 12 Implementation phase flowchart for the contaminant assessment framework

The project developed a framework for identifying contaminants of concern (CoC) that may be dispersed in flood waters during and after flood events (Figure 12). The framework is designed to be applied during the emergency management cycle planning and prevention stages, to assist in managing the impacts of CoCs when a flood occurs (DoJ 2018). The framework is intended for use across any waterways within NSW and provides steps and technical advice on how to identify CoCs during different stages of flooding, depending on land uses within each waterway’s catchment. For more information, see the separately published *Conceptual framework for flood event water quality contaminant assessment* report.
