Cadia region surface water testing report

August 2024

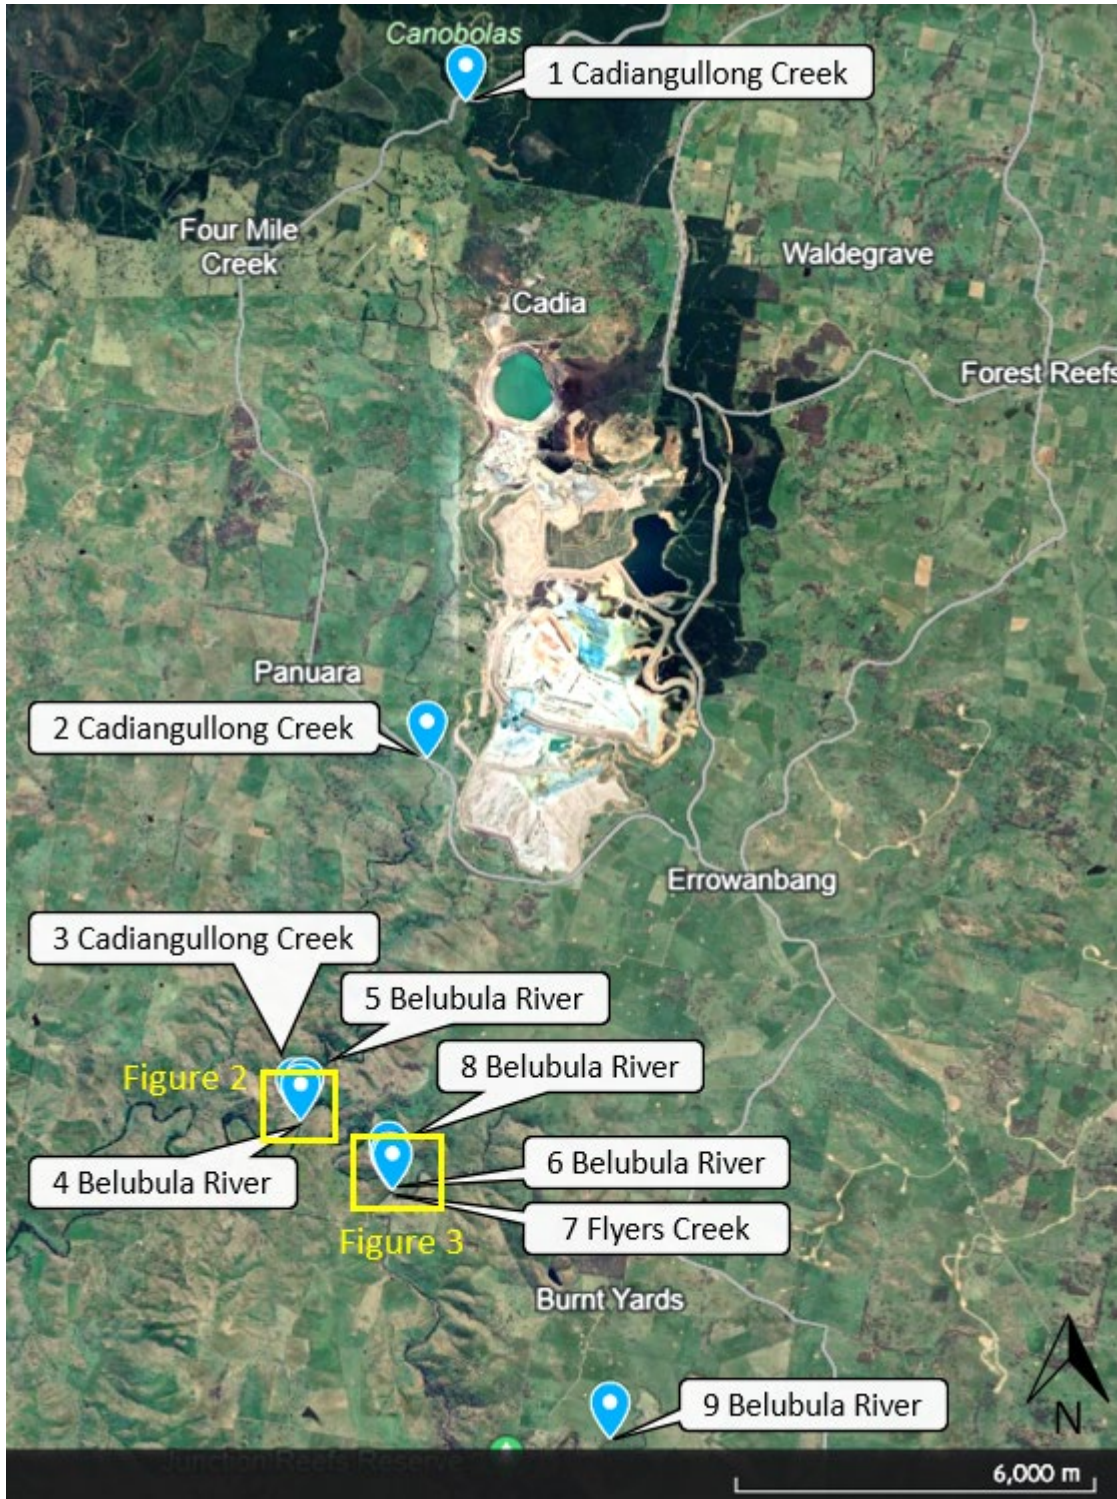
Figure 1 Overview of the sampling sites

On 30 May 2024 the EPA collected surface water samples from nine locations along Cadiangullong Creek, Flyers Creek and Belubula River, both upstream and downstream of the mine (see Figure 1). The sampling sites were selected with consideration for the proximity to the mine, accessibility and previous sampling in the area. We included sampling sites near the confluence of the Cadiangullong Creek and Belubula River, and the confluence of Flyers Creek and the Belubula River, because community members leasing the surrounding land for livestock grazing have raised concerns regarding the potential suitability of the waterways for livestock drinking water.
