McGraths Hill, Mulgrave, Windsor Field Ambient Odour Assessment Study

*Prepared for the NSW Environment
Protection Authority*

Final Report

August 2013

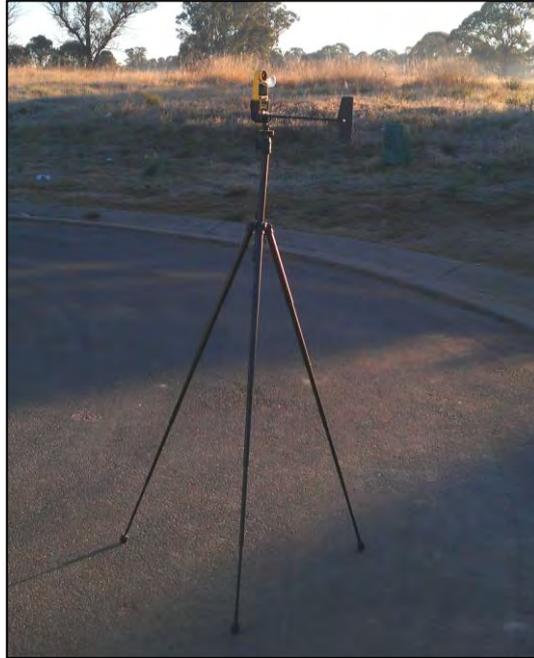
Photo 4.1 – Kestrel Anemometer apparatus in operation

Meteorological conditions were recorded using a Kestrel 4500 Pock Weather Tracker Anemometer (see **Photo 4.1** for illustration of setup). At each measurement point on the maps, the team would setup the anemometer apparatus enabling for real-time measurement of local temperature, wind speed and direction at a measurement location point over each assessment measurement event. This was undertaken during every survey at each measurement point.

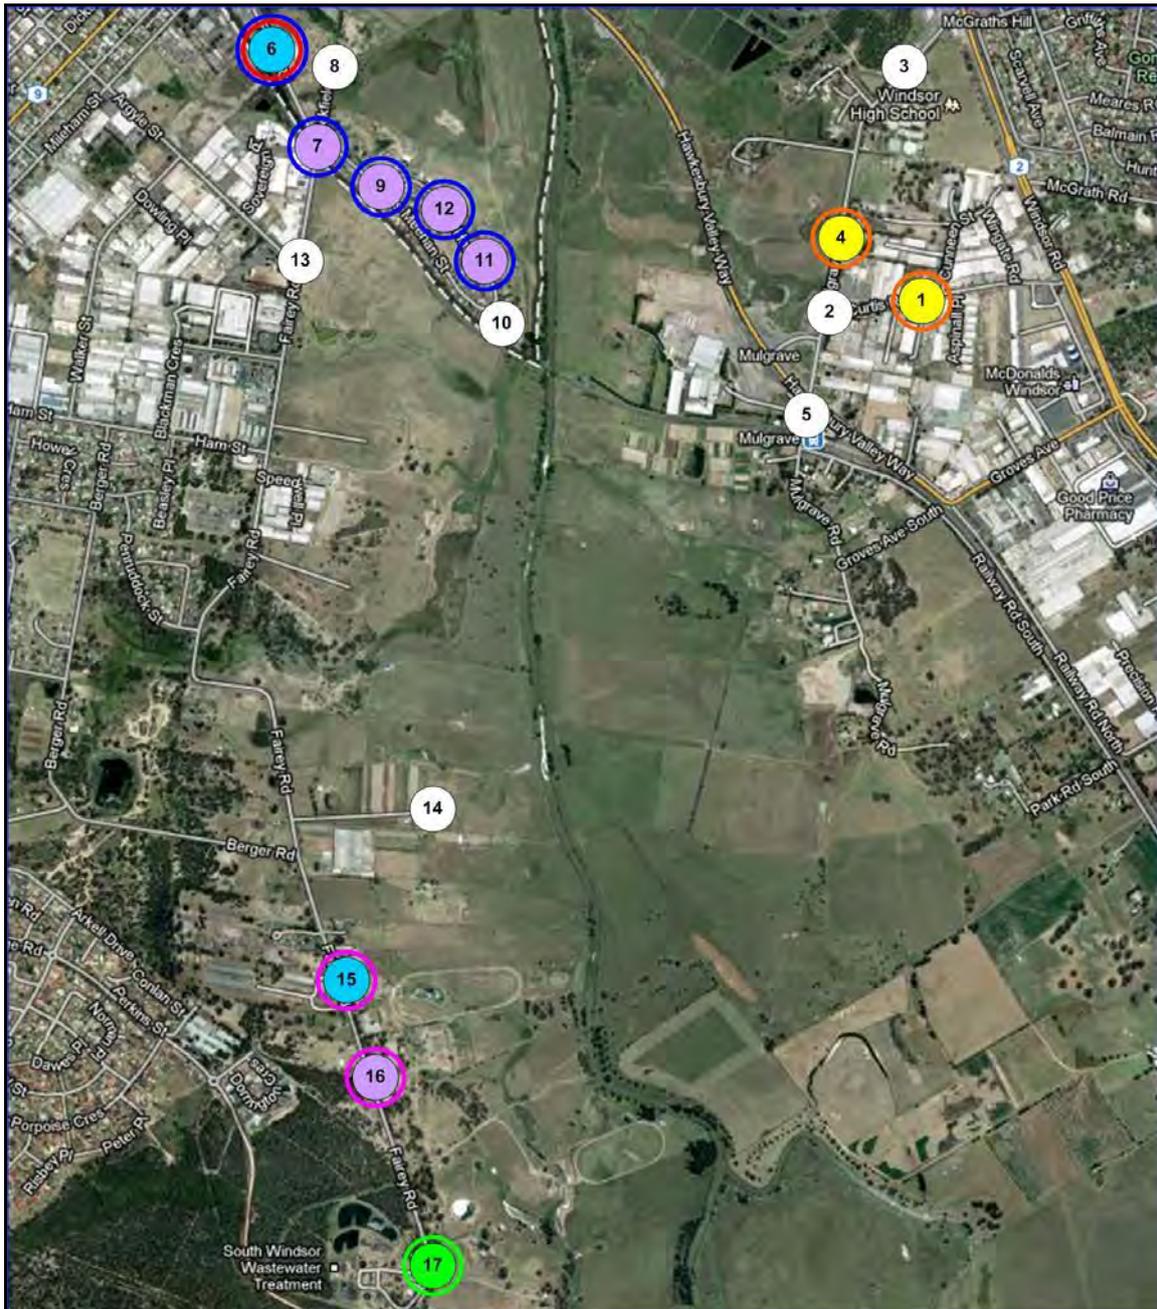
FAOA Survey Map Plot 5.1 – FAOA Survey No.1: 27 May 2013

FAOA Survey No. 1 was carried out on 27 May 2013 between 1545 hrs - 1752 hrs. The wind conditions at the time of this assessment session were calm to very light winds, tending predominately from the east. Local wind direction varied during the survey.

- Further along Fairey Rd to the south there were instances of Distinct to Strong poultry shed odours at MLPs 15 and 16. The odour detected was that of the live birds, rather than that of chicken manure/manure. These locations were close to the boundary of a broiler chicken farm. The absence of any measurable wind at these locations is thought to be the reason for the detection of the poultry shed odours at these locations.

- At MLP 17, at the front gate of the South Windsor Sewage Treatment Plant, a Weak sewage odour was detected.

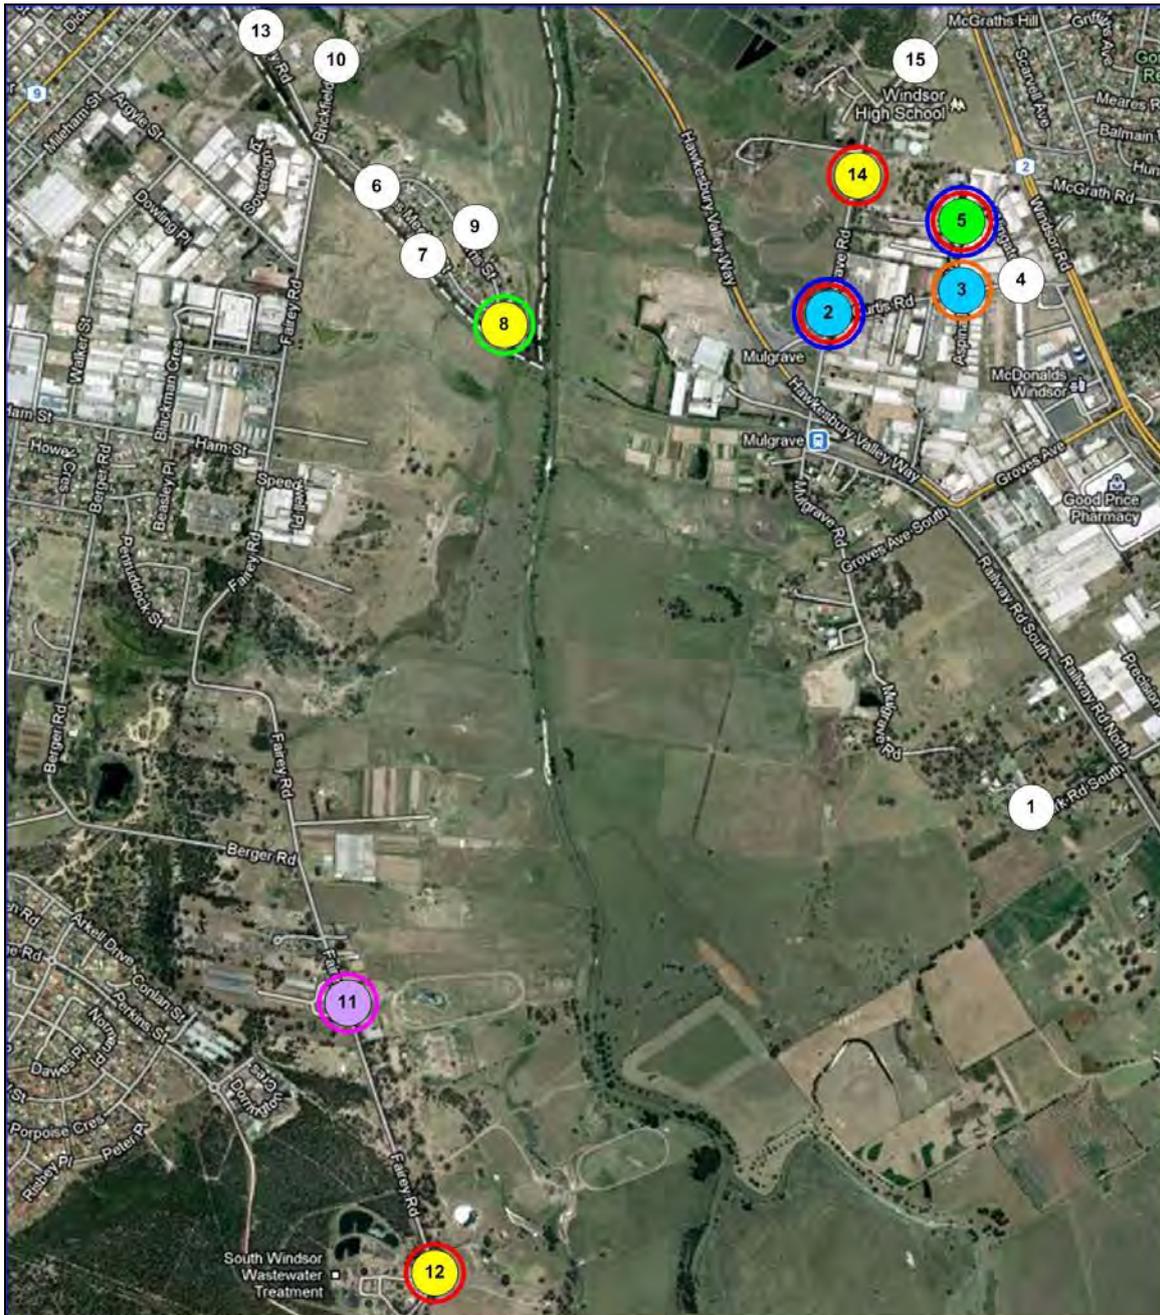
FAOA Survey Map Plot 5.2 – FAOA Survey No. 2: 29 May 2013

FAOA Survey No. 2 was carried out on 29 May 2013 between 1440 hrs – 1632 hrs. The wind conditions at the time of this assessment session were calm to very light winds, tending predominately from the south-west. Local wind direction varied during the survey.

- In Fairey Rd at MLP 11 a Strong and constant poultry shed and ammonia odour was detected, consistent with the location being close to the poultry broiler farm

- Similarly, at MLP 12, at the front gate of the South Windsor Sewage Treatment Plant, a Very Weak sewage odour was intermittently present.

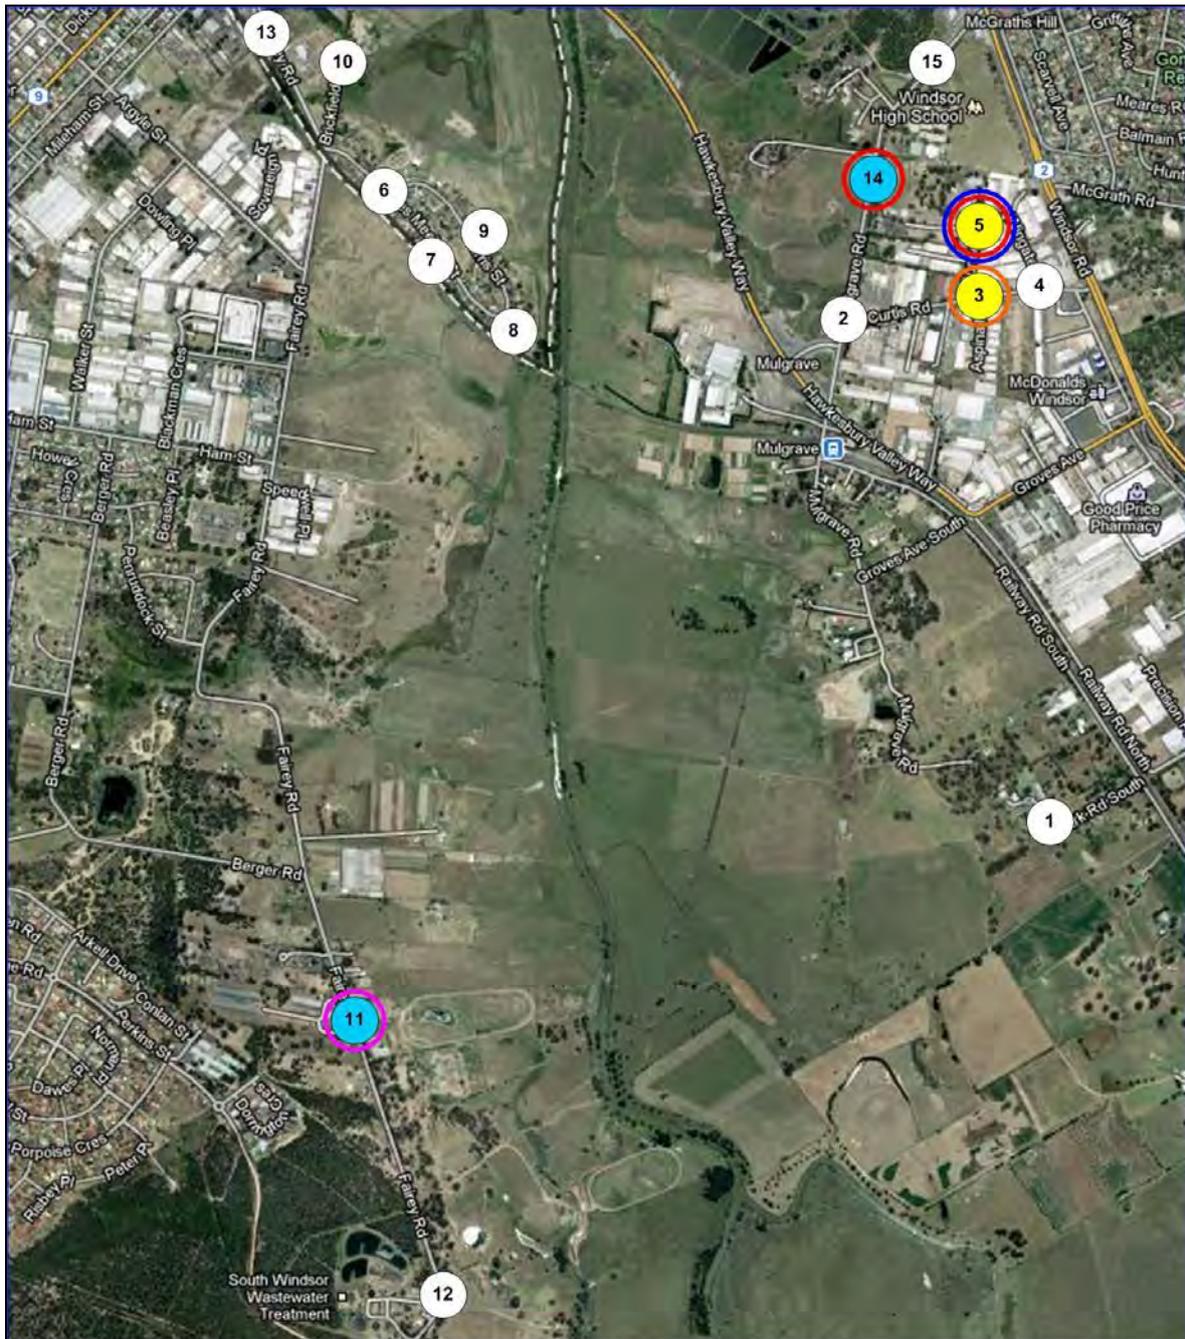
FAOA Survey Map Plot 5.3 – FAOA Survey No. 3: 29 May 2013

FAOA Survey No. 3 was carried out on 29 May 2013 between 1712 hrs - 1845 hrs, which was 40 minutes after the completion of FAOA Survey No. 2. The same wind conditions prevailed, being calm to very light winds, tending predominately from the south-west. Local wind direction varied during the survey.

- Towards the end of this survey, at MLP 14 in Mulgrave Rd, a constant and Distinct Compost odour was found to be present. This odour had none of the Chicken manure character found previously in the area, and was judged to have emanated from the Elf Farm, possibly the tunnel composting building.

- In Fairey Rd at MLP 11 a Strong and constant poultry shed and ammonia odour was again present, consistent with the location being close to the poultry broiler farm

- There was no odour at MLP 12, outside the front gate of the South Windsor Sewage Treatment Plant.

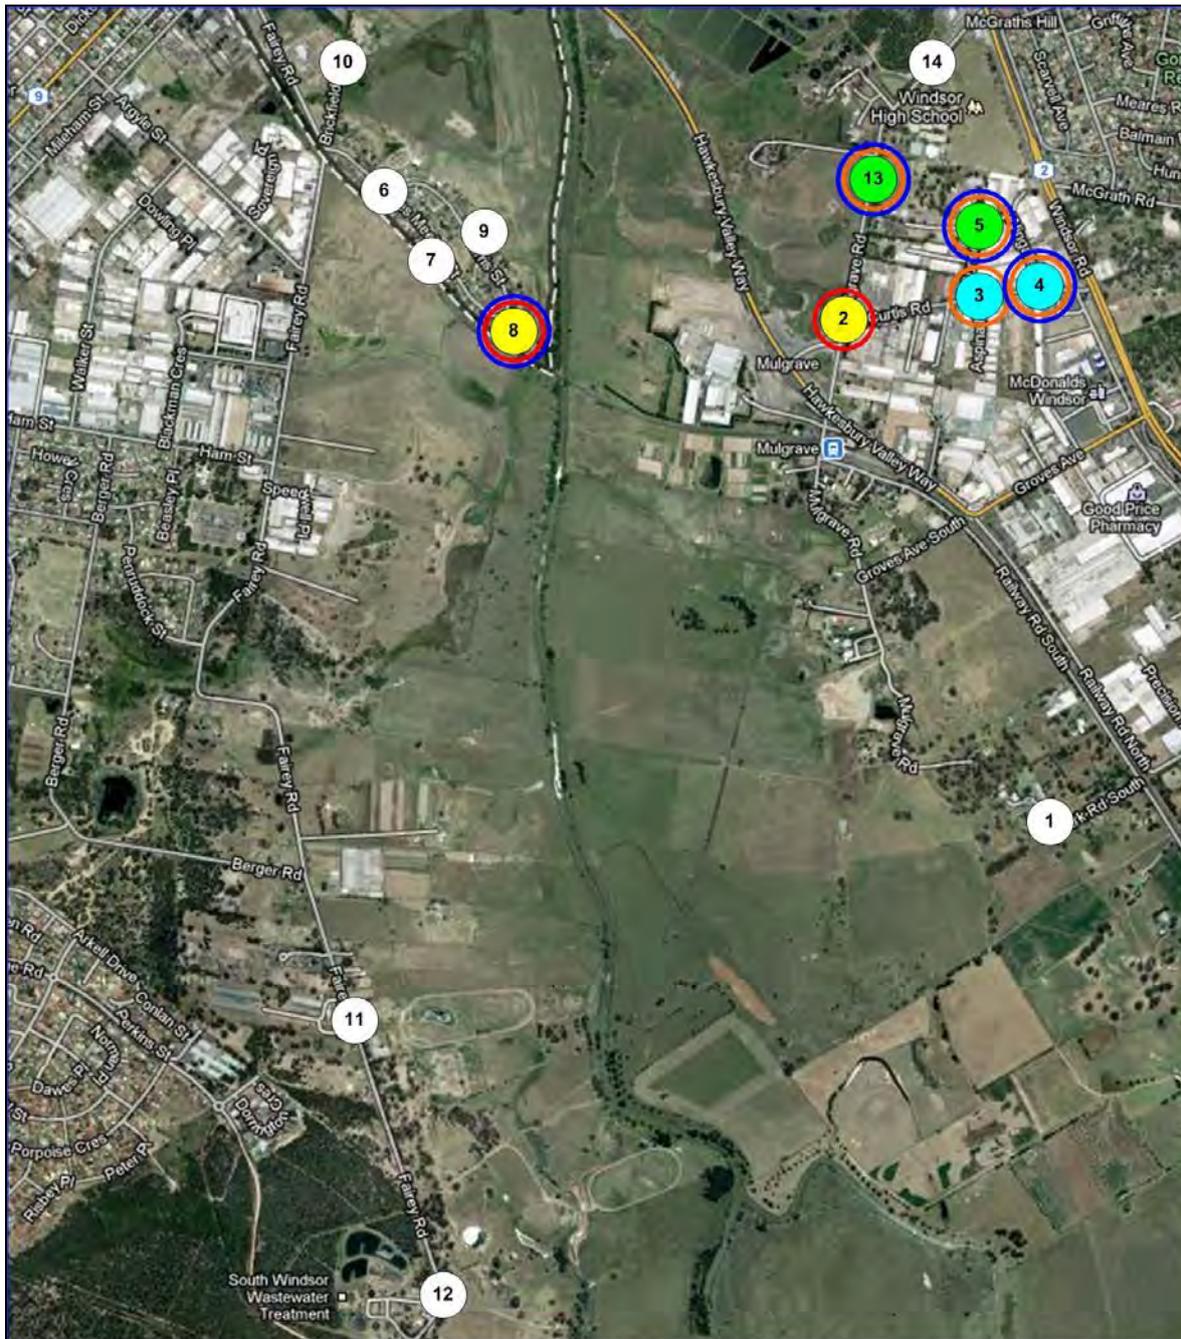
FAOA Survey Map Plot 5.4 – FAOA Survey No. 4: 3 June 2013

FAOA Survey No. 4 was carried out on 3 June 2013. The wind conditions at the time of this assessment session were once again calm to very light winds, varying between south-west to easterly. Local wind direction often changed suddenly during the survey, with the result that swirling light winds were often present in the built-up areas.

- At MLPs 3 and 4, in Curtis and Cunneen Streets respectively, a mixed odour was detected constantly at Weak to Distinct levels. This odour was judged to consist of the Chicken manure Elf Farm odour combined with the Meal odour from the pet food factory. Approximately 90 minutes later the survey team returned to this area and found the same odour at MLP 13 in Mulgrave Rd. This odour was not pursued further than these locations.

- A transient similar odour was detected at MLP 8 at the junction of Harris and James Meehan Streets in the residential area to the west of the Elf plant, at intensity level Very Weak. The wind direction at that time was from the east. This odour was not considered to be significant.

- There was no odour at MLP 12, outside the front gate of the South Windsor Sewage Treatment Plant or at MLP 11, outside the broiler poultry farm in Fairey Rd.

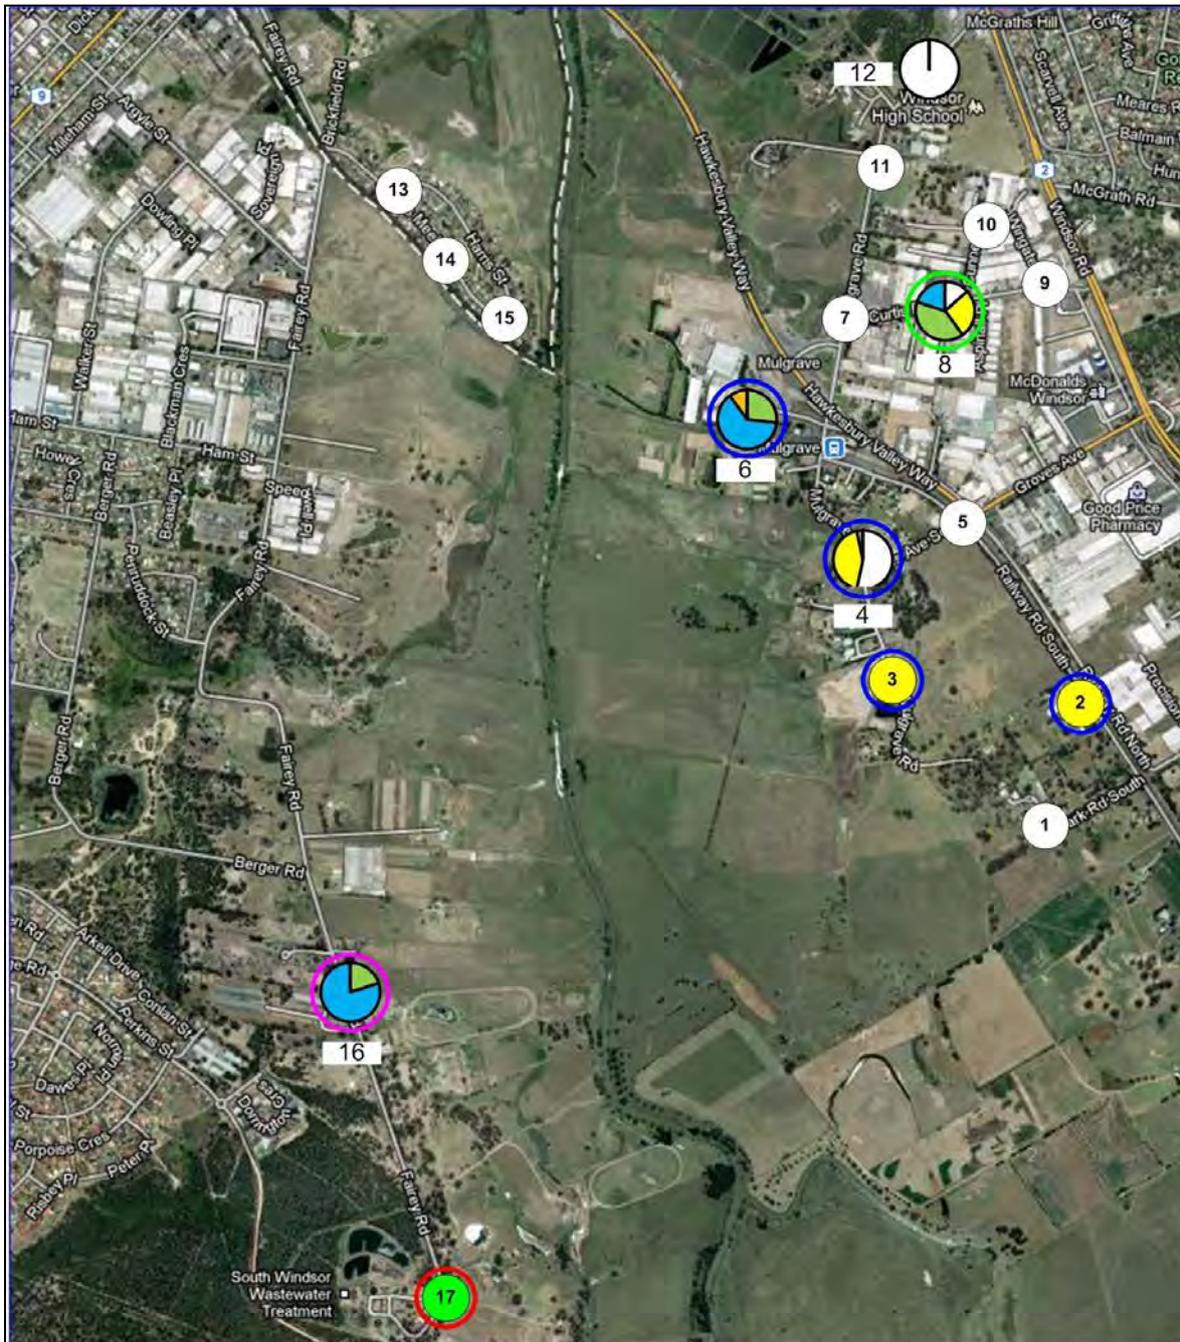
FAOA Survey Map Plot 5.5 – FAOA Survey No. 5: 13 June 2013

FAOA Survey No. 5 was carried out on 13 June 2013 between 1434 hrs - 1710 hrs. The wind conditions at the time of this assessment session were very light winds, from the north-west. Local wind direction was consistent for the duration of the survey. This was the first survey carried out under north-westerly winds. This was also the first survey in which 5-minute assessments were carried out at key locations

- The pet food factory Meal odour was not detected during this survey. In its place, in Curtis Rd, an intermittent industrial odour was present, at levels from Very Weak to Distinct. This odour had a Chemical/Solvent/Metallic character. Its source could not be identified.

- As with previous surveys, the poultry farm was detected constantly, at levels up to Distinct, outside the farm in Fairey Rd at MLP 16. Similarly, there was a Weak Effluent/Mildew odour present at MLP 17, outside the front gate of the South Windsor Sewage Treatment Plant. While slightly different to previous odour characters determined at this location, this odour is considered to have originated at the plant.

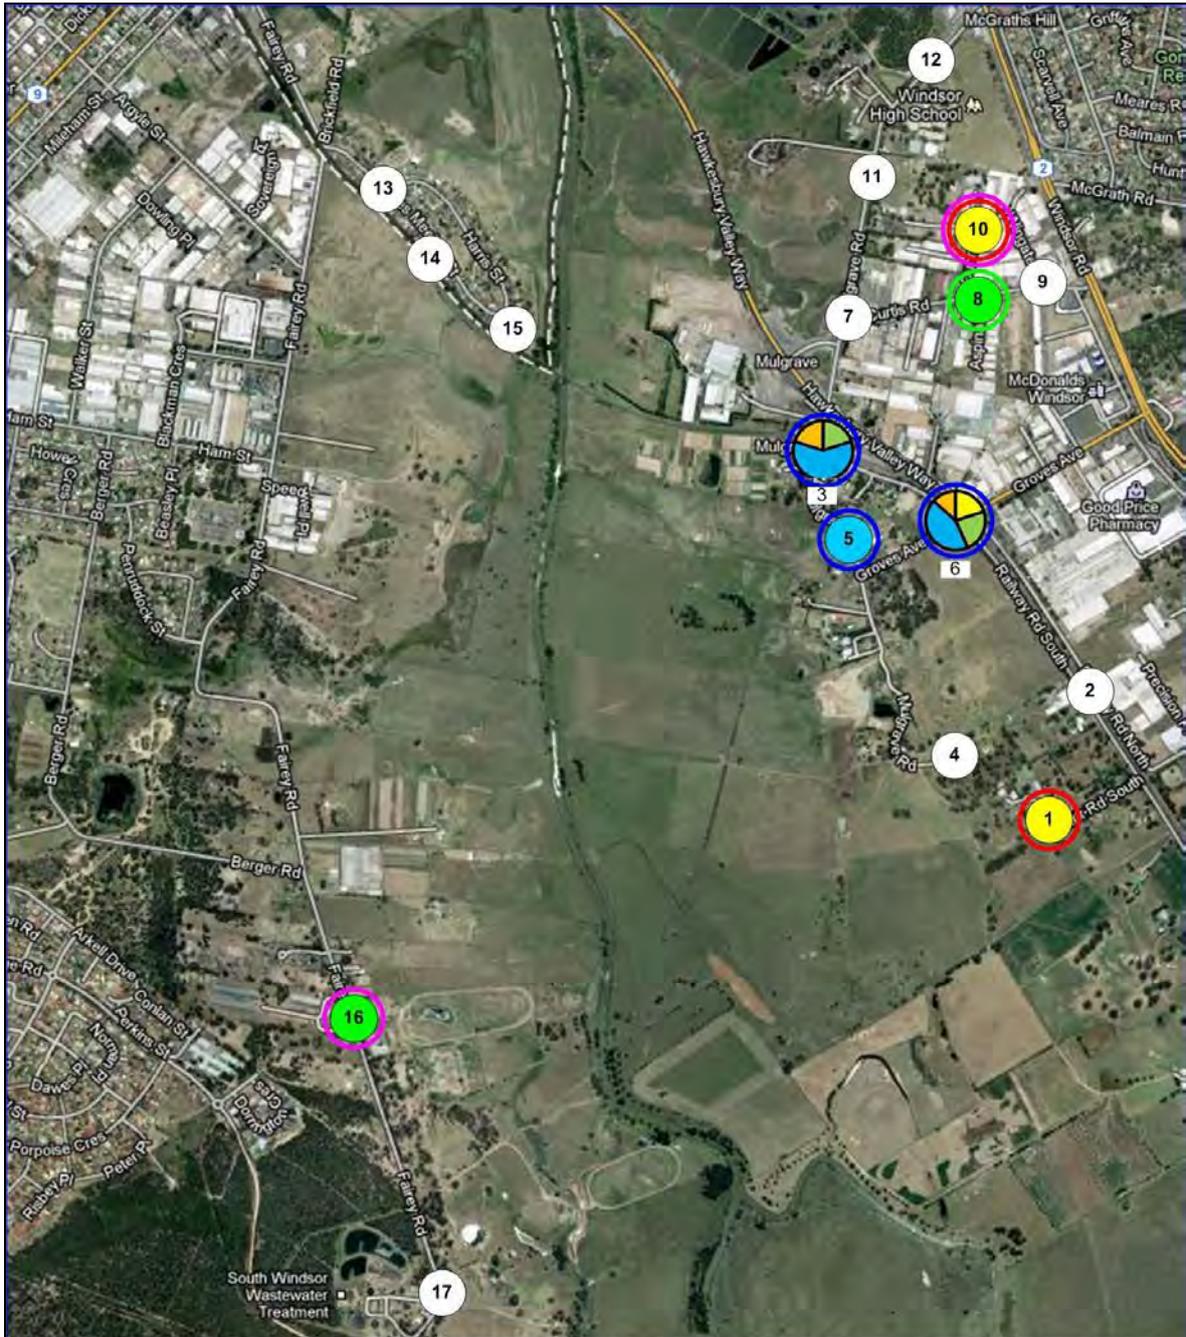
FAOA Survey Map Plot 5.6 – FAOA Survey No. 6: 14 June 2013

FAOA Survey No. 6 was carried out on 14 June 2013 between 1402 hrs – 1605 hrs. The wind conditions at the time of this assessment session were light to moderate winds, mostly from the north-west. This survey was the only one carried out under winds stronger than 1 m/s.

- At the northern end of the industrial estate a Very Weak and intermittent Poultry/Earthy/Compost odour was detected at MLP 10. Nearby, at MLP 8 the previously reported Chemical odour was detected, as a Resin/ Solvent odour. This also appeared to be localised in its impact.
- To the south-east of the Elf Farm plant at MLPs 3, 5 and 6 the characteristic Chicken manure odour was found to be present at intensity levels up to Distinct. This odour was continuous at MLP 6 near the junction of Groves Ave and Railway Rd North, approximately 600m from the Elf plant.
- The poultry farm in Fairey Rd was again detected on the roadway (MLP 16).
- An unknown intermittent and Very Weak Earthy/Compost odour was detected in Park Rd South (MLP 1). This odour appeared to be from a local source.
- The McGraths Hill STP was not detected during this survey at the downwind locations MLP 11 and MLP12.

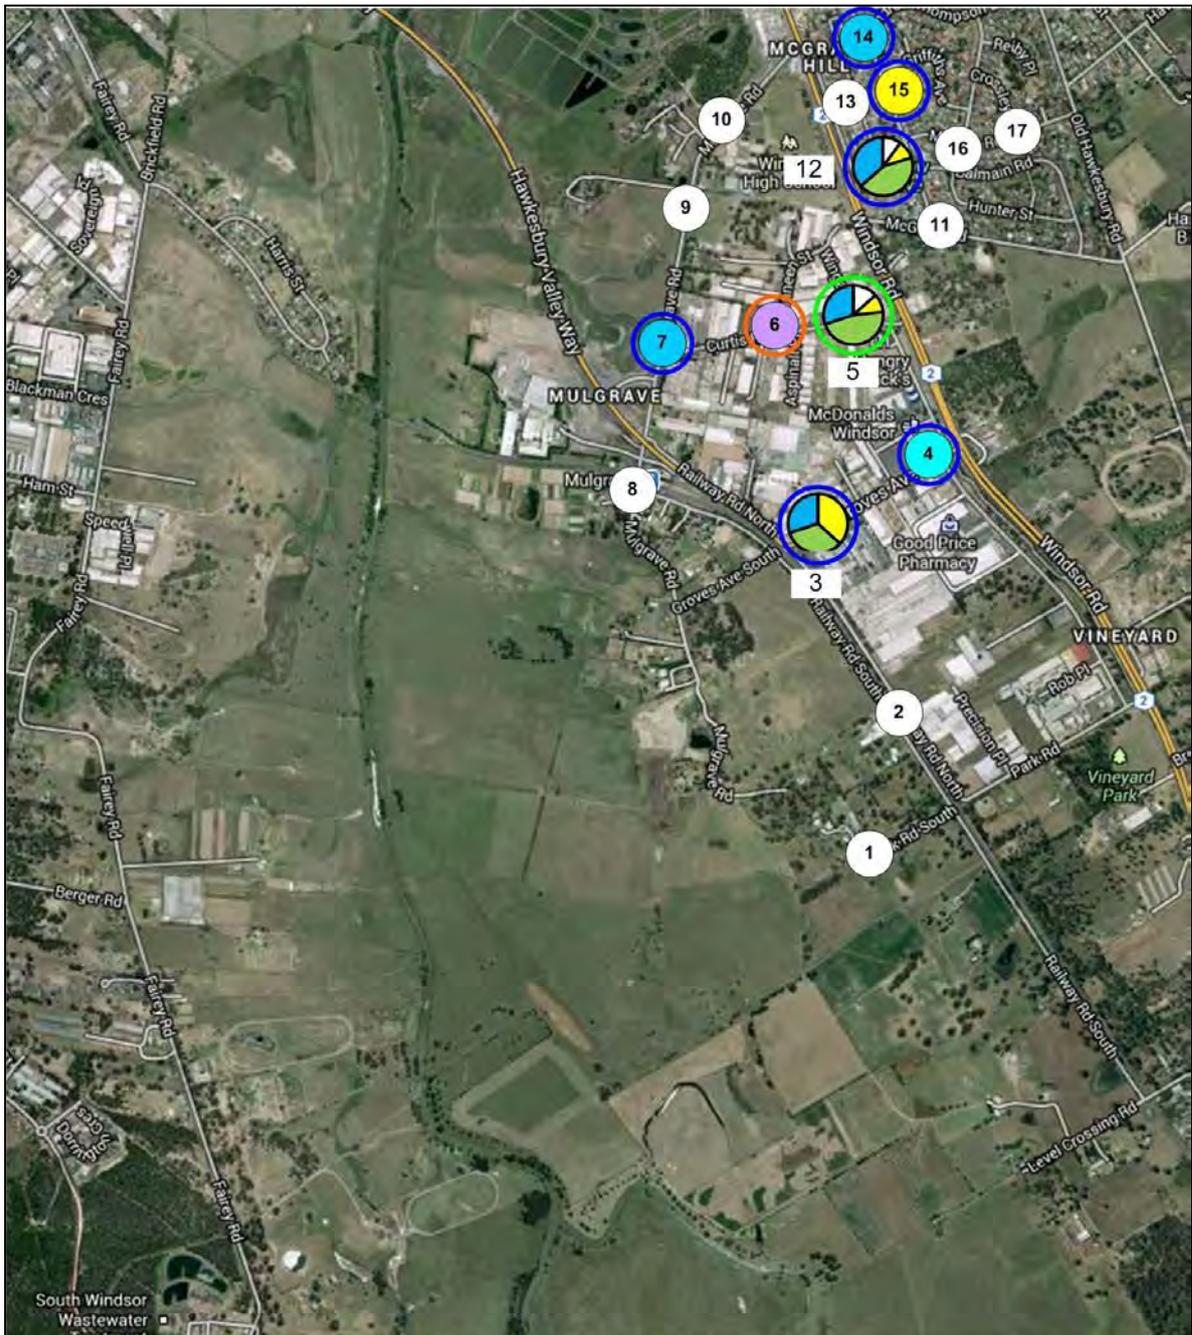
FAOA Survey Map Plot 5.7 – FAOA Survey No. 7: 24 June 2013

FAOA Survey No. 7 was carried out on 24 June 2013 between 1120 hrs – 1415 hrs. The wind conditions at the time of this assessment session were very light winds, swinging around from the north-east initially to the south-west. The latter part of this survey was the first carried out under consistent south-westerly winds. These winds directed any odours from the Elf Farm and pet food plants towards the McGraths Hill residential area.

- At MLP 3, near the junction of Groves Ave South and Railway Rd North, the Chicken manure odour was constantly present, under a north-westerly wind, at levels up to Distinct. This location is approximately 600m from the Elf plant. It was also detectable at a similar intensity at MLP 4, slightly to the east, more than 1,000m from the plant.

As the wind direction changed towards the south-west the same Chicken manure odour was tracked from near the Elf plant at MLP 7 (Distinct) to the corner of Red House Cr and Andrew Thompson Drive, McGraths Hill (MLP 14), a distance of approximately 1,100m from the Elf plant. While intermittent and at intensity Distinct at this location, this odour was also detected more consistently up to this level in the residential area at MLP 12, approximately 950m from the plant.
